GUNDAGAI RAILWAY BRIDGE AND VIADUCTS – CONVERSION TO RAIL TRAIL

Feasibility Report

01 MAY 2018

Report No F0001-10005572-NSR-01

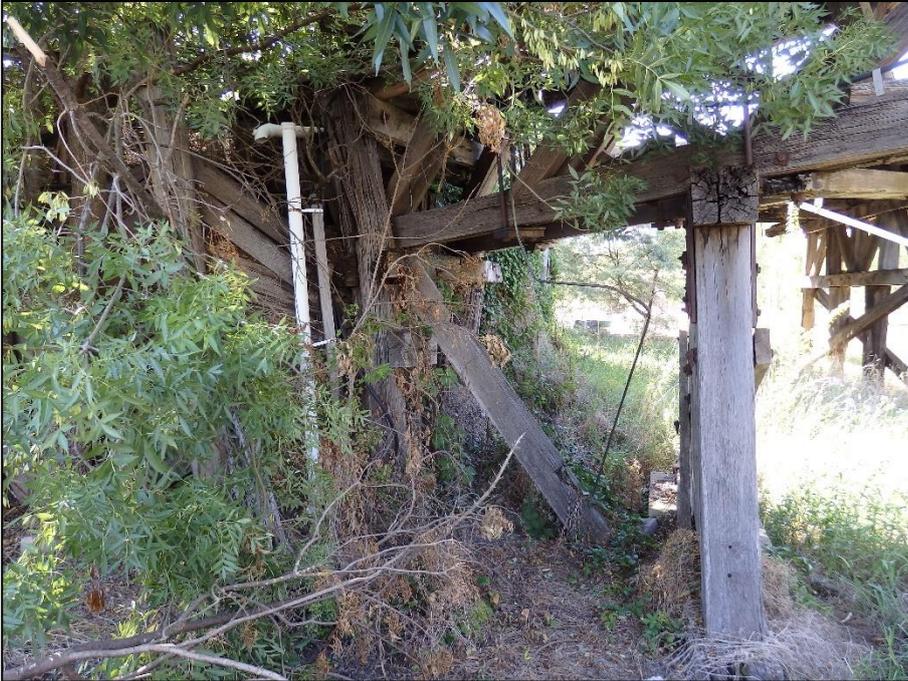
Sydney Abutment (February 2018):

- Sydney abutment (Abutment 1) dilapidated – In poor condition and is partially collapsed, piles broken, timber sheeting fractured. It is noted there is a supplementary timber trestle located close to the defective abutment, to provide additional support close to the end of the truss. Refer Plate 11, Appendix B.

The indicative cost estimate is based on replacing 30% of all timber pier trestle elements (including piles, cross-bracing, headstocks and walings) and replacing both timber abutments in their entirety.

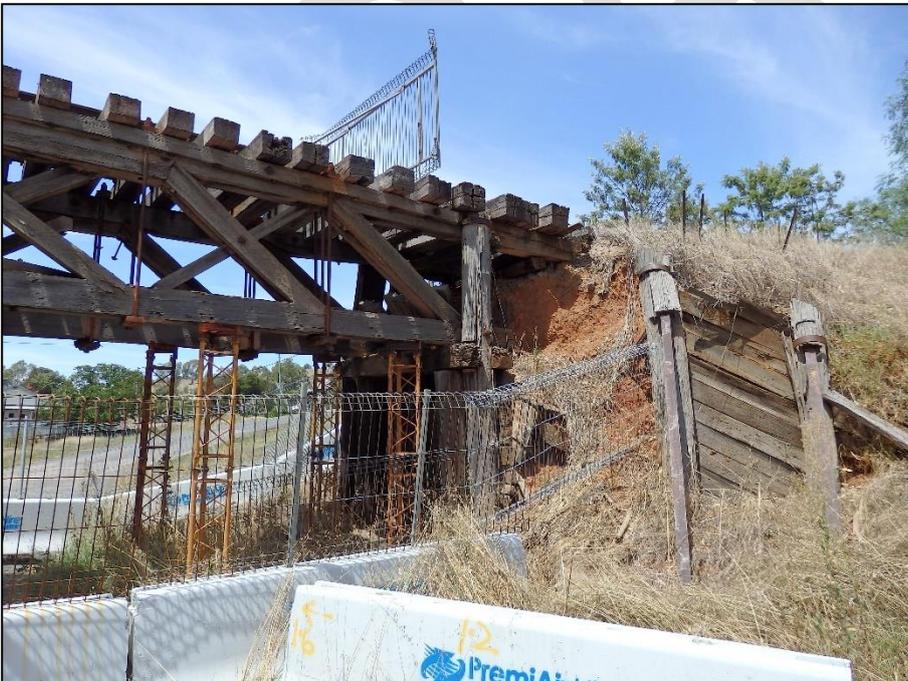
Country Abutment (February 2018):

- Country abutment (Abutment 2) dilapidated – In poor condition with dislodged and broken timber sheeting, embankment scoured out during 2012 flood.
- Abutment 2 – Headstock deteriorated at ends.

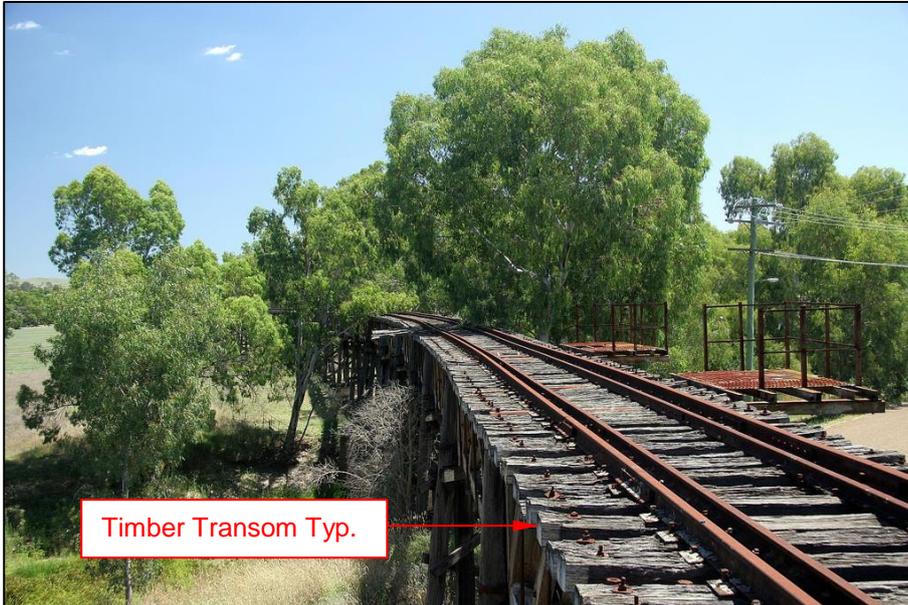
As the proposed shared path decking system will be supported by the timber transoms (larger version of sleepers), it is recommended that many of these be replaced, as they are very likely in deteriorated condition. As the overall length of the bridge and viaducts is approximately 925 metres, it is estimated that

The indicative cost estimate is based on replacing 50% of all timber transoms. Transoms are typically 250 mm W x 165 mm D x 2850 mm long.

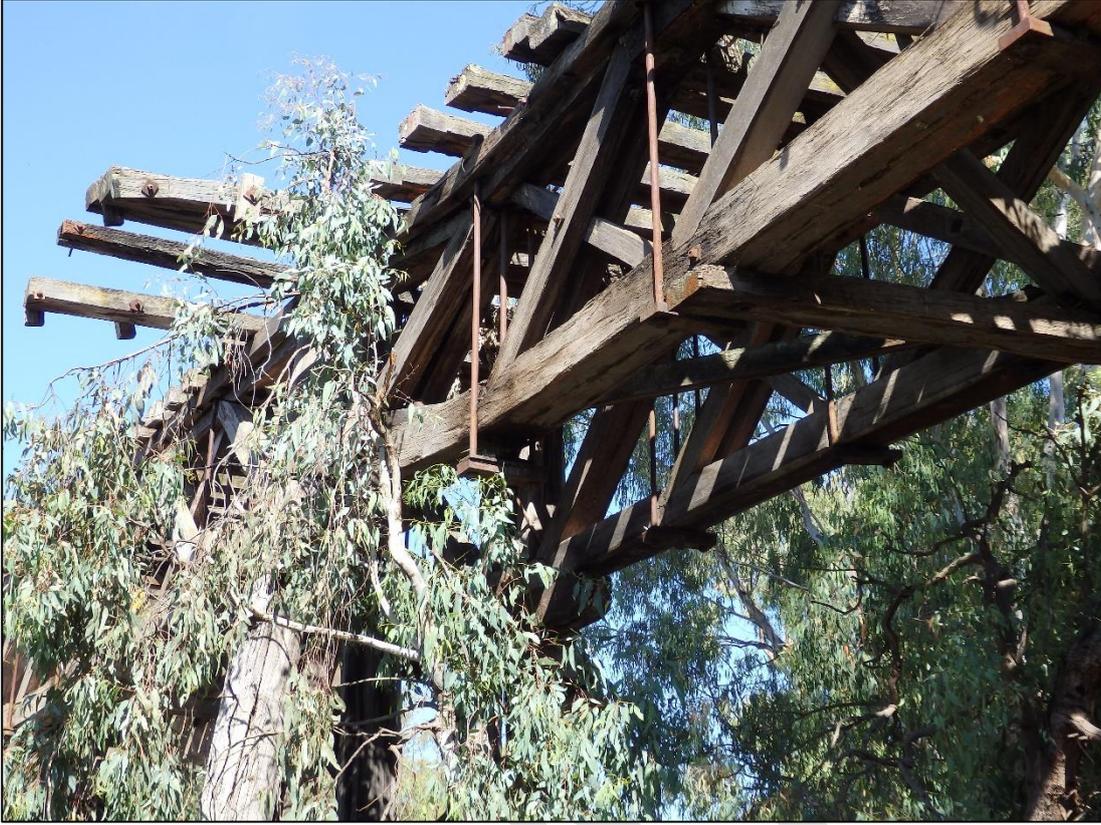
- Span 4 (Down side truss) – Top and bottom chord fractured (near Trestle 4). Refer Plate 1, Appendix B.
- Span 25 (Up side truss) – Top chord of 2nd panel and top chord of 4th panel severe decay (total loss of timber). Bottom chord weathered and split. Refer Plate 2, Appendix B.

Plate 1 – Fractured Top & Bottom Chords, Span 4, Down Side Truss (near Trestle 4)

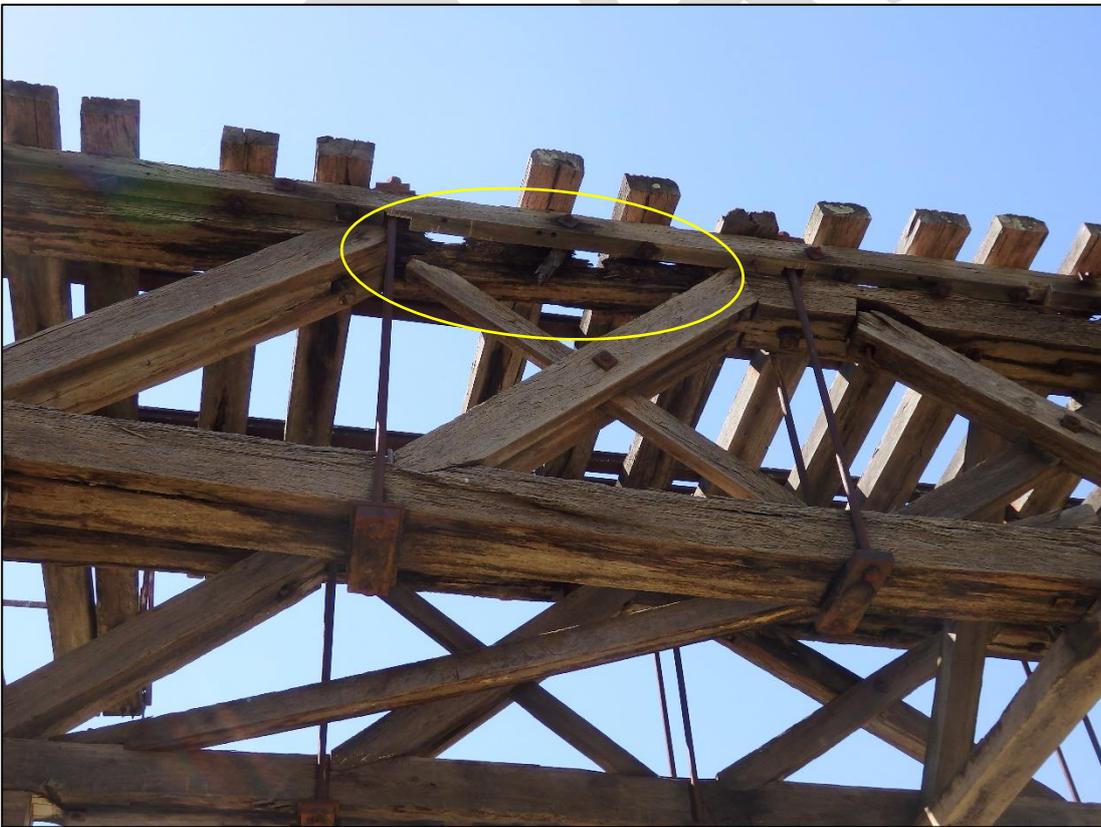
Plate 2 – Severe Decay at Top Chord, Span 25, Up Side Truss

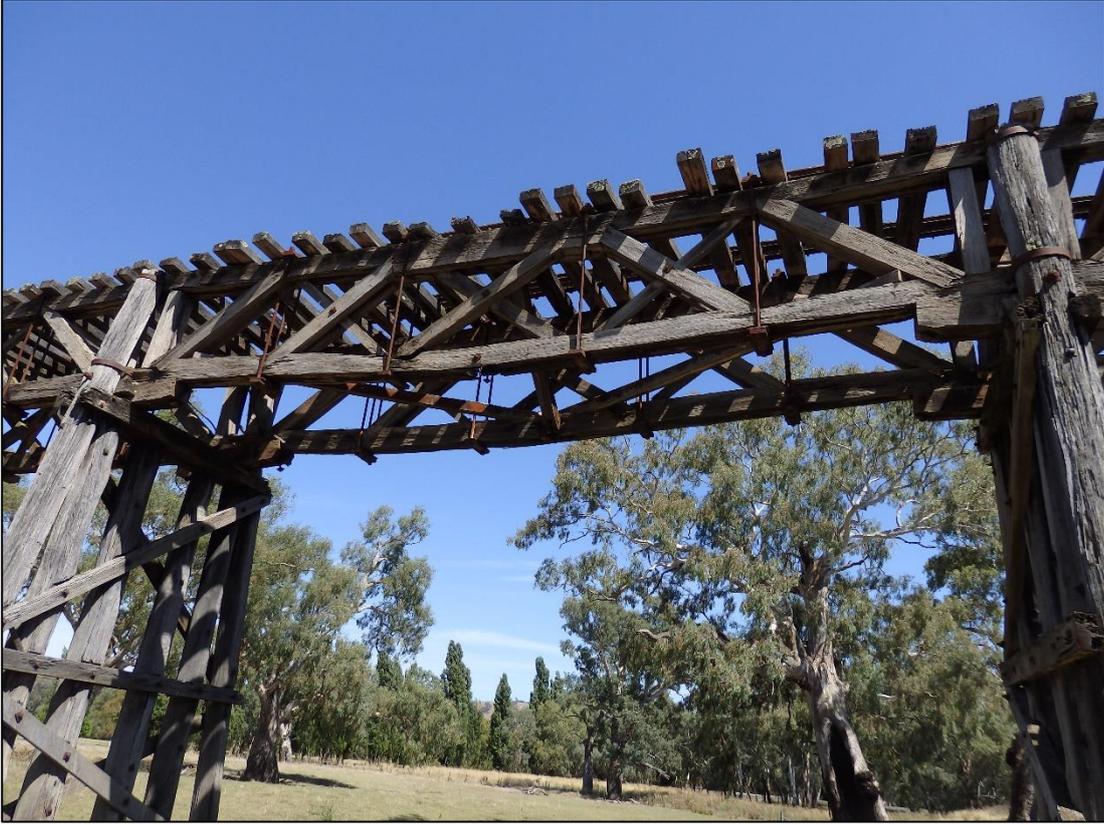
- Span 30 (Up side truss) – Severe decay of top chord at 4th panel point.
- Span 49 – Detached bottom chord cross beam.
- Span 51 – Total fracture of bottom chords of each truss (at mid-span). Refer Plate 3, Appendix B.
- Span 54 – Up side bottom chord decayed at interface with missing corbel (at Trestle 53). Bottom chord has dropped onto cap sill following loss of corbel. Refer Plate 4, Appendix B.
- Transoms severely weathered and split throughout length of viaducts and bridge spans. Also, transoms are ‘bunched up’ at a number of locations.

Plate 3 – Fractured Bottom Chord, Span 51, Up Side & Down Side Trusses

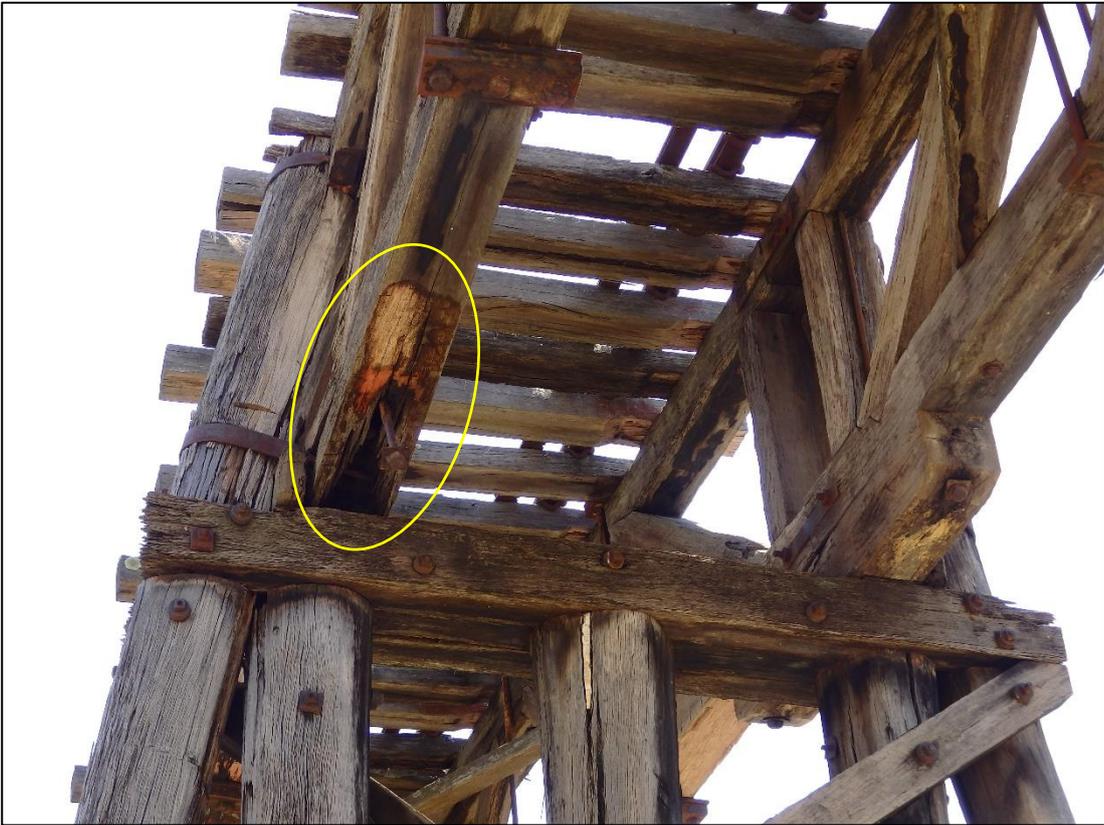
Plate 4 – Missing Corbel & Bottom Chord Decayed, Span 54 (at Trestle 53), Up Side Truss

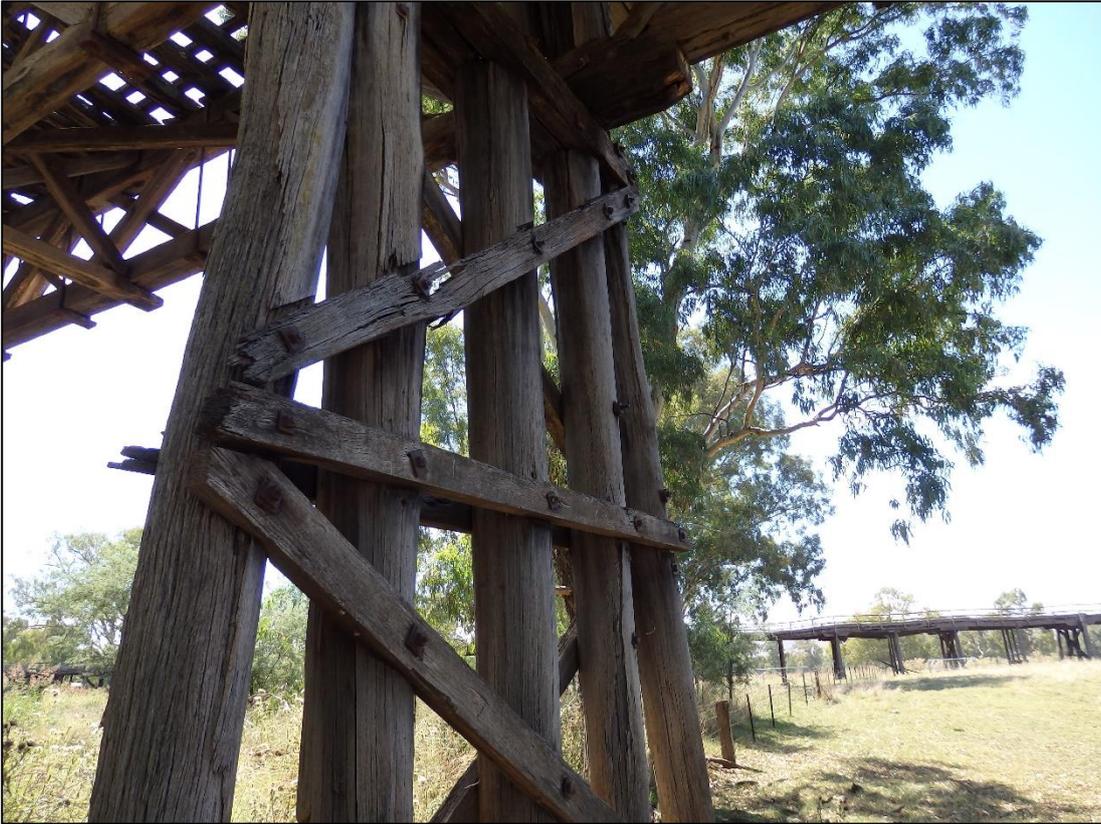
- Trestle 16 – Decayed bottom waling and decayed upper cross-bracing. Refer Plate 5, Appendix B.
- Trestles 17 to 22 (inclusive) – Decayed bottom walings. Refer Plate 6, Appendix B.

Plate 5 – Decayed Upper Cross-Bracing, Trestle 16

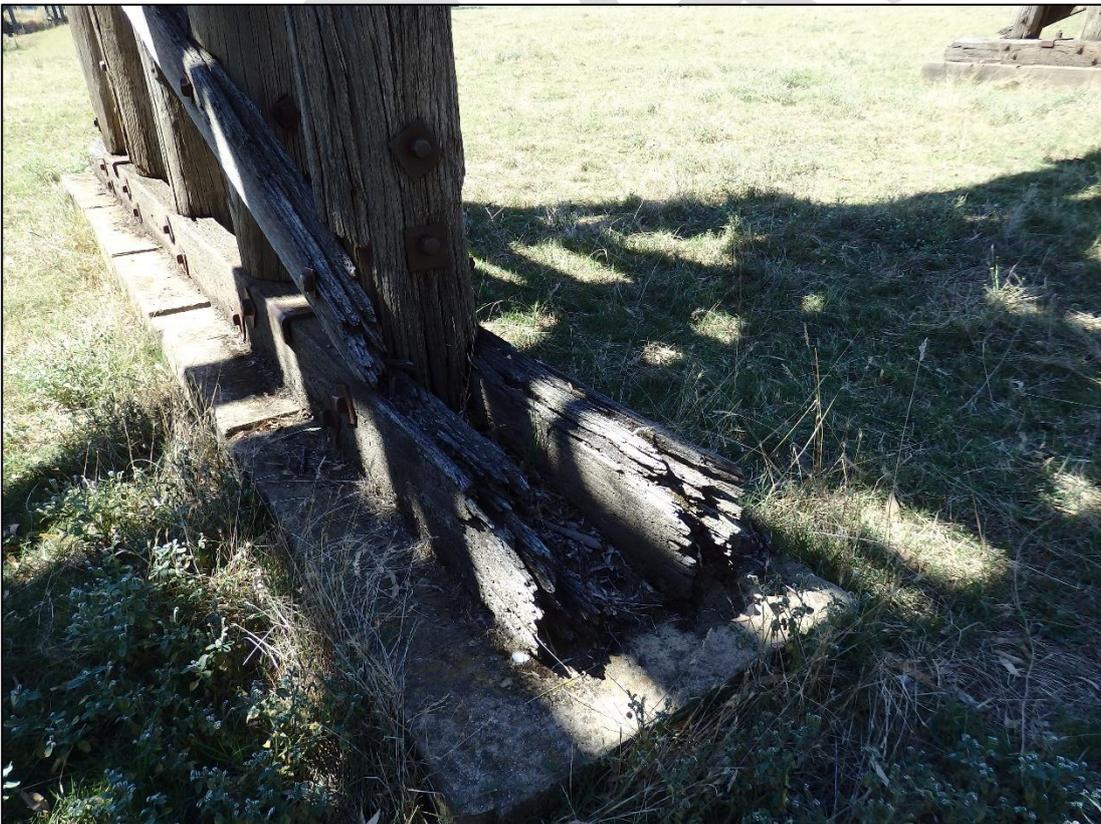
Plate 7 – Decayed Bottom Walings (Typical for Trestles 17 to 22 (inclusive))

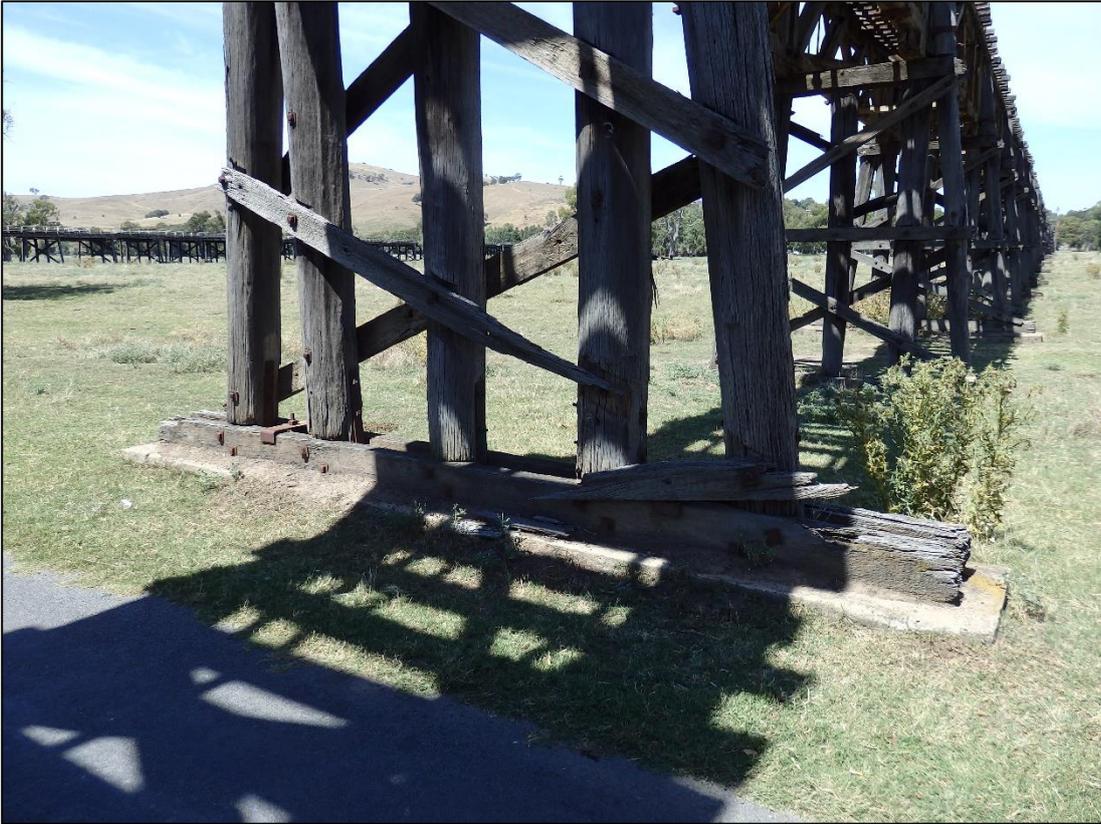
- Trestle 23 – Broken cross-bracing. Refer Plate 7, Appendix B.
- Trestle 24 – Severely weathered bottom walings. Cross-bracing broken (on one side).
- Trestle 26 – Severely deteriorated bottom waling. Refer Plate 8, Appendix B.

Plate 8 – Broken Lower Cross-Bracing, Trestle 23

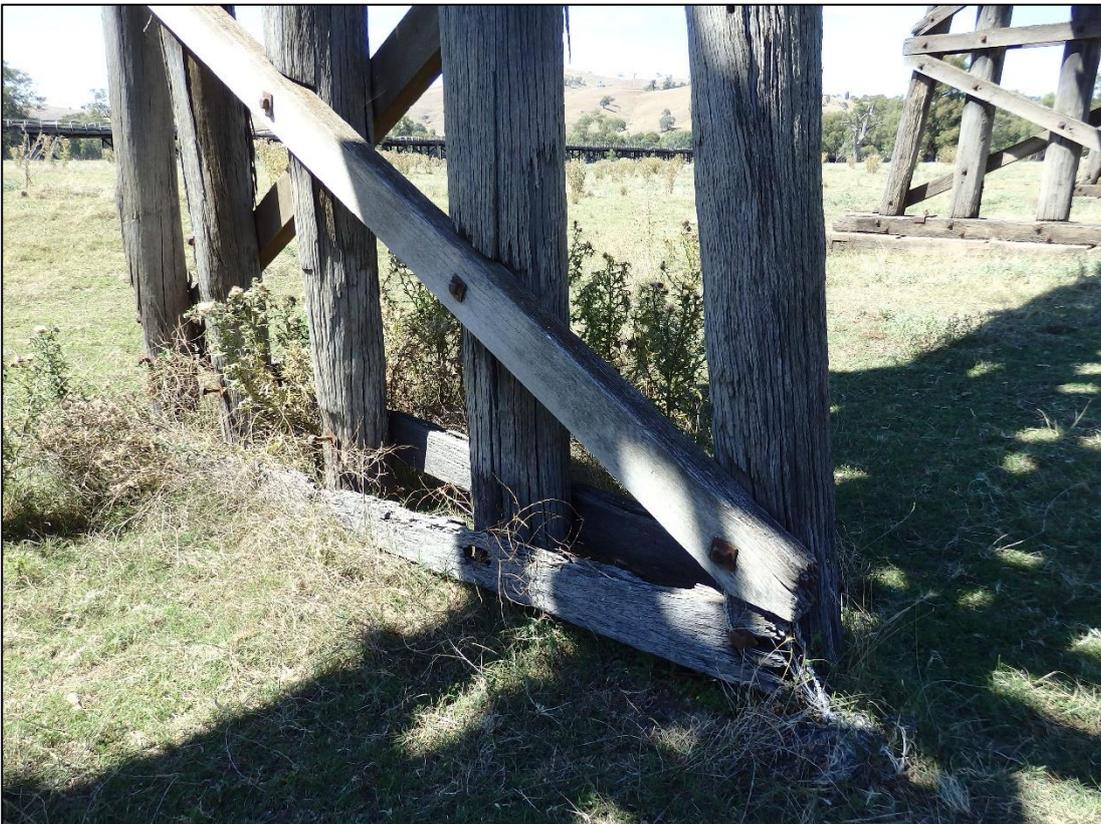
Plate 9 – Severely Deteriorated Bottom Waling, Trestle 26

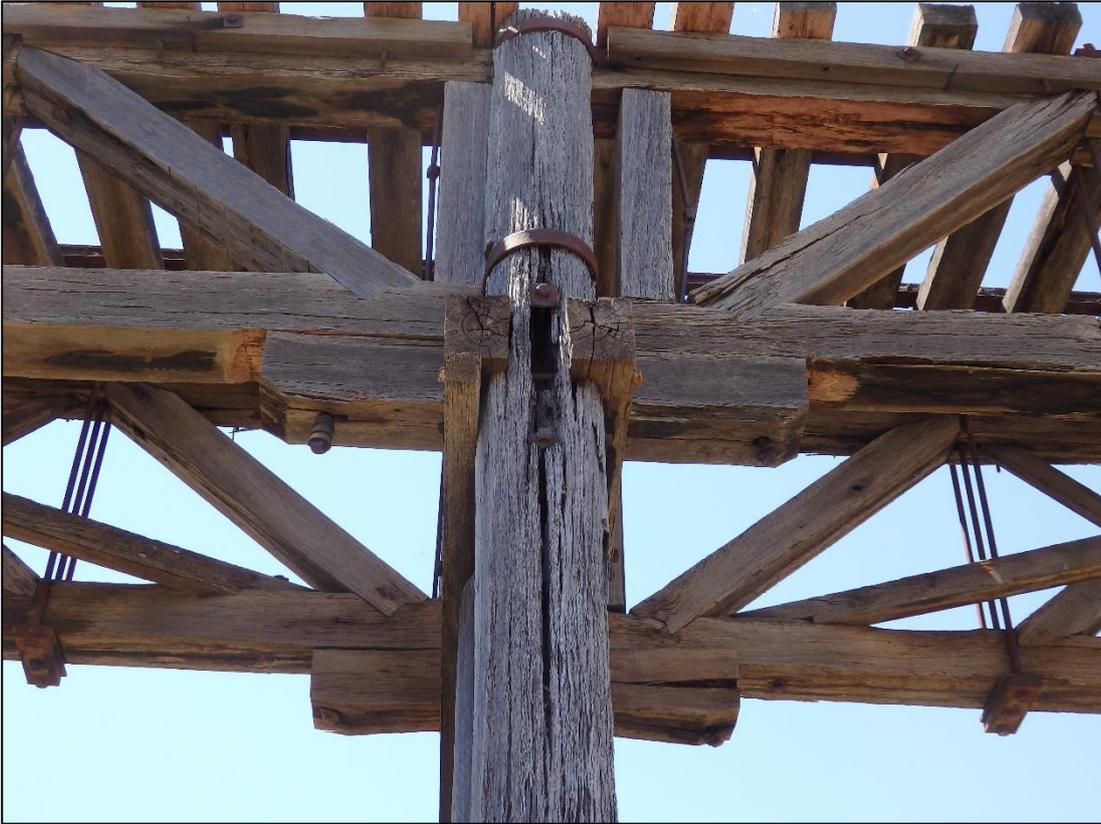
- Trestle 27 – Severely deteriorated/missing timber at bottom waling.
- Trestle 29 – Severely deteriorated bottom waling.
- Trestle 39 – Down side column has vertical split. Also, severe decay at top. Refer Plate 9, Appendix B.

Plate 10 – Split & Decay, Down Side Pile, Trestle 39

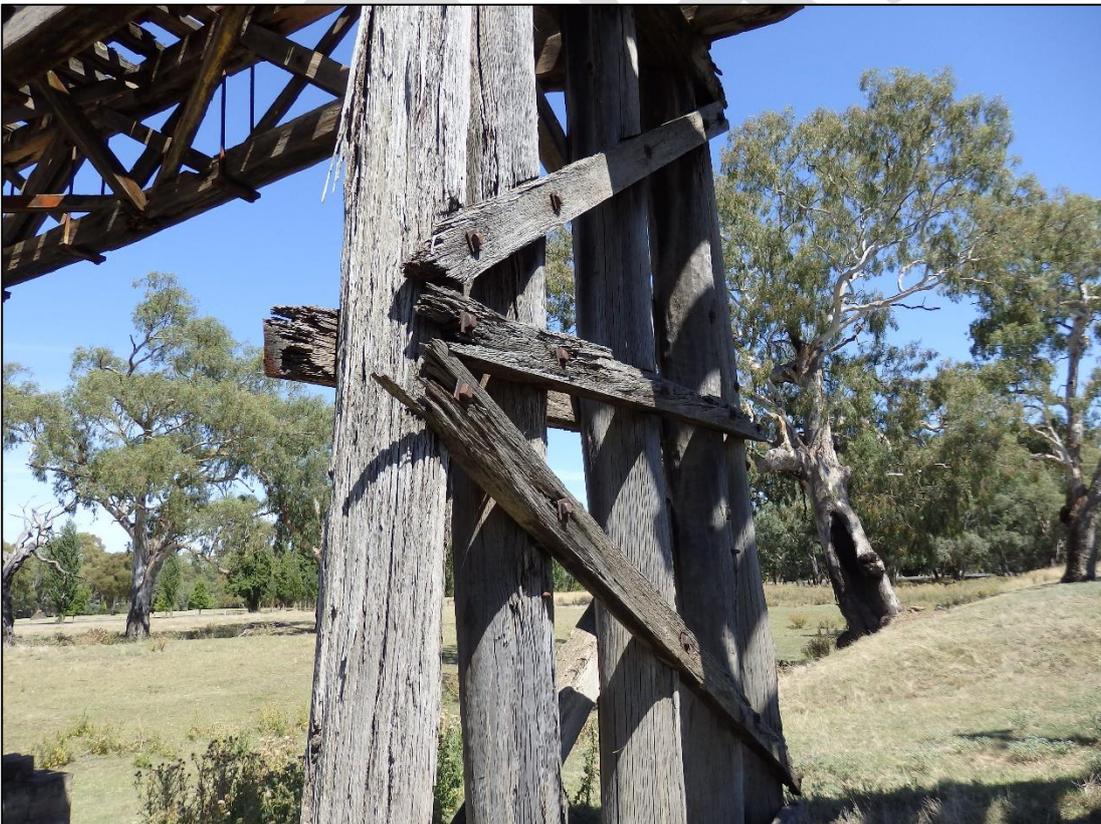
- Trestle 50 – Totally deteriorated bottom walings and severely deteriorated mid-height waling. Refer Plate 10, Appendix B.
- Trestle 54 – Cross-bracing cut. Mid-height waling decayed.

Plate 11 – Deteriorated Mid-Height Walings, Trestle 50

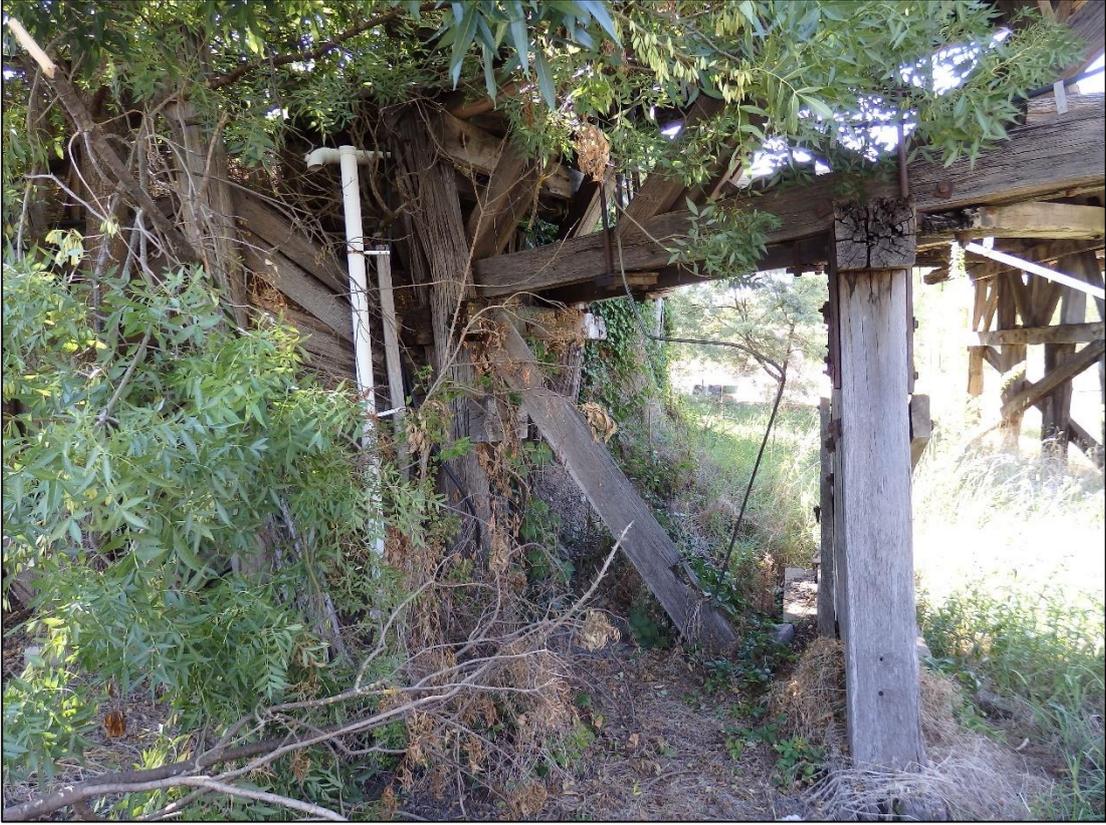
Plate 12 – Dilapidated Abutment 1

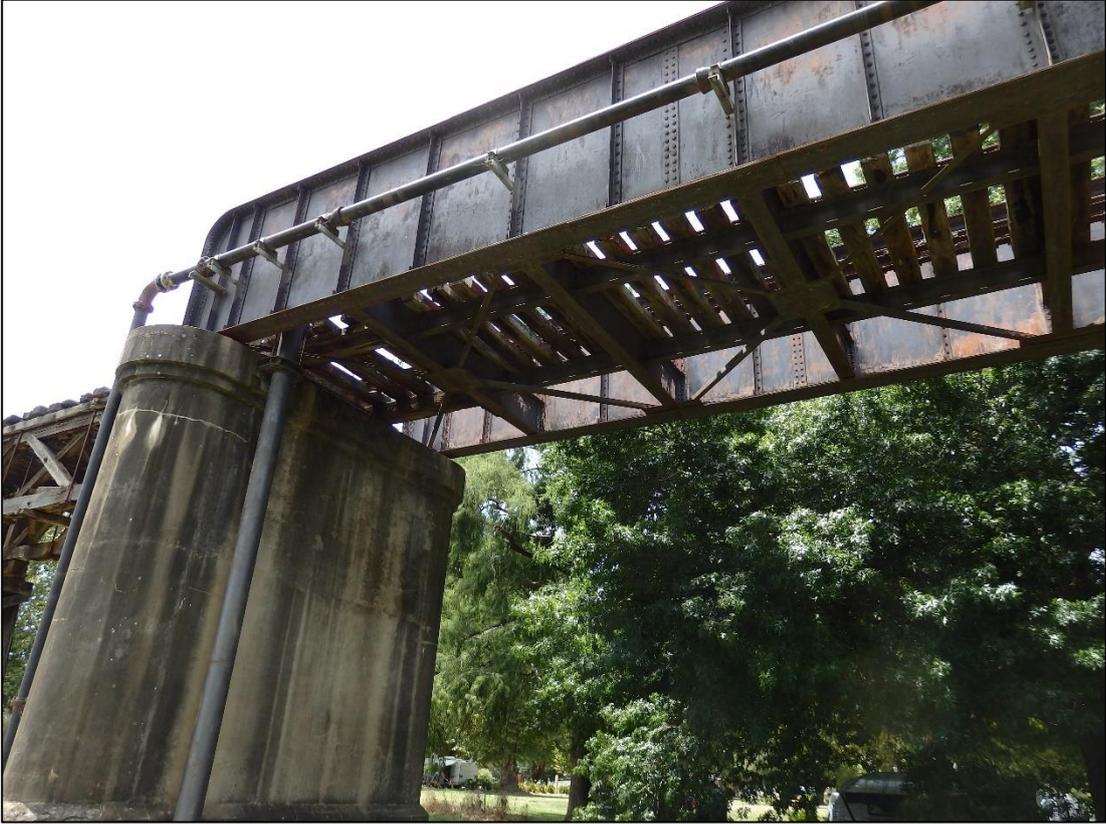
Plate 13 – Span 73

- Span 73 (half-through girder) – Steelwork appeared (from a distance) in fair to good condition, apart from loss of paintwork throughout and subsequent surface rust throughout. Refer Plate 12, Appendix B.
- Span 75 (half-through girder) – Steelwork appeared (from a distance) in fair to good condition, apart from loss of paintwork throughout and subsequent surface rust throughout. Refer Plate 14, Appendix B.

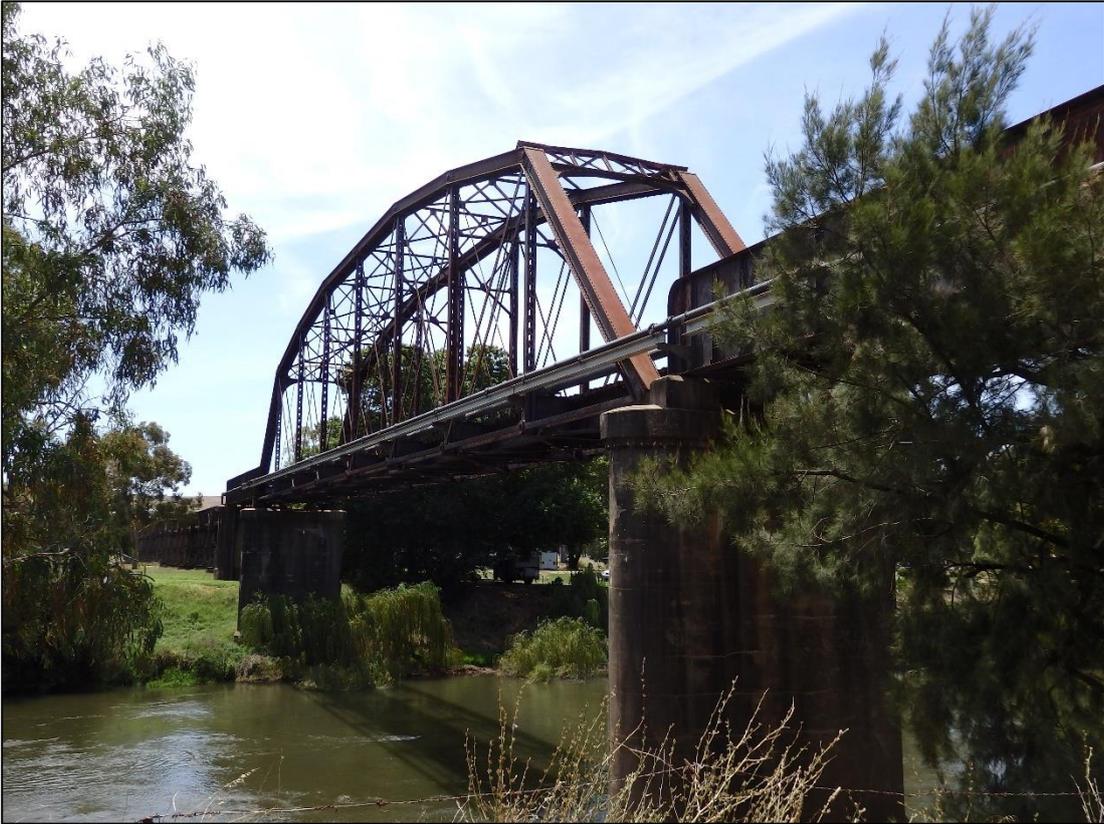
Plate 14 – Span 74

- Span 74 (truss) – Apart from loss of protective paintwork on all steel elements, and subsequent surface rust throughout, the steel truss span appeared (from a distance) to be in fair to good condition. Refer Plate 13, Appendix B.

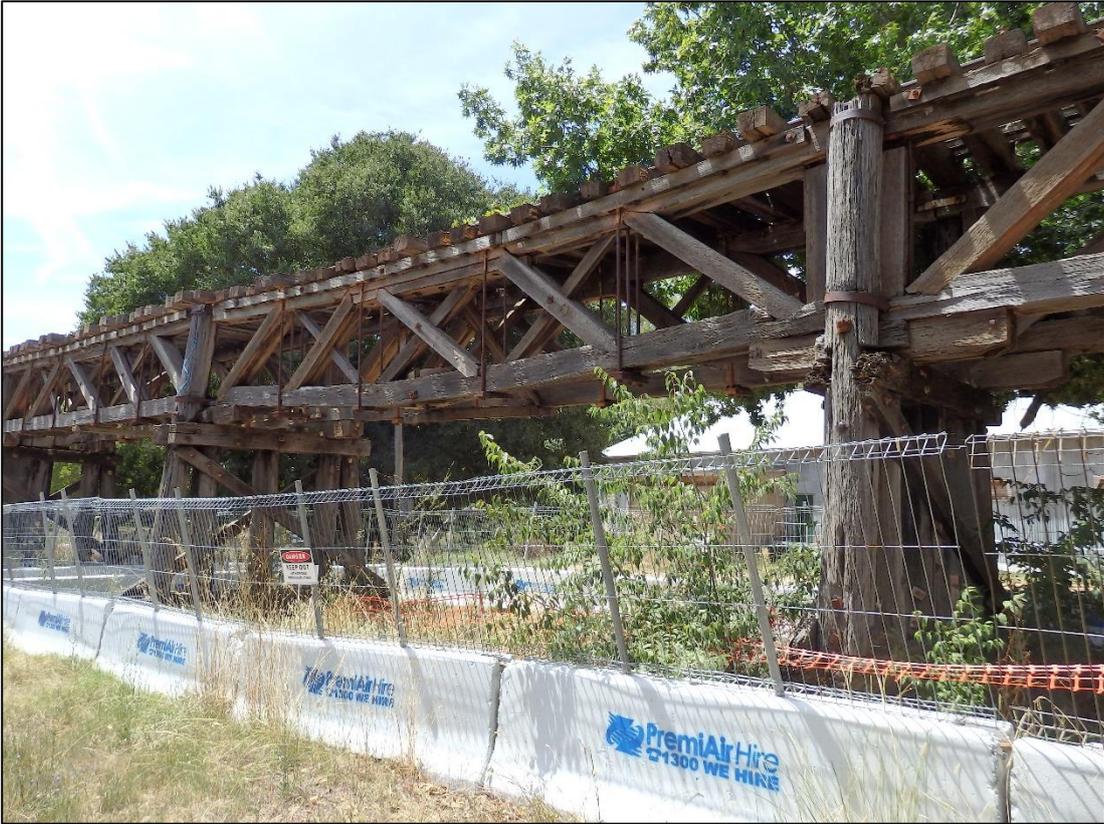
There is significant sag of the Up side truss of Span 78, which is the middle span of the five spans of the Southern Viaduct. It was noted that the Up side bottom chord truss end at Trestle 77 has decayed, resulting in dislodgement of the end post of the truss and disconnection with the bottom chord of the adjacent truss span, thereby causing it to sag, but still resting on the corbel. Essentially, the triangulated truss members have lost their 'tightness' and the entire truss has deflected like a beam element.

- Span 78 – Up side truss sagging.
- Span 78 – Up side bottom chord crushed (near Trestle 78).
- Span 78 – Up side bottom chord entirely decayed locally (near Trestle 77).

Plate 16 – Sagging Up Side Truss, Span 78

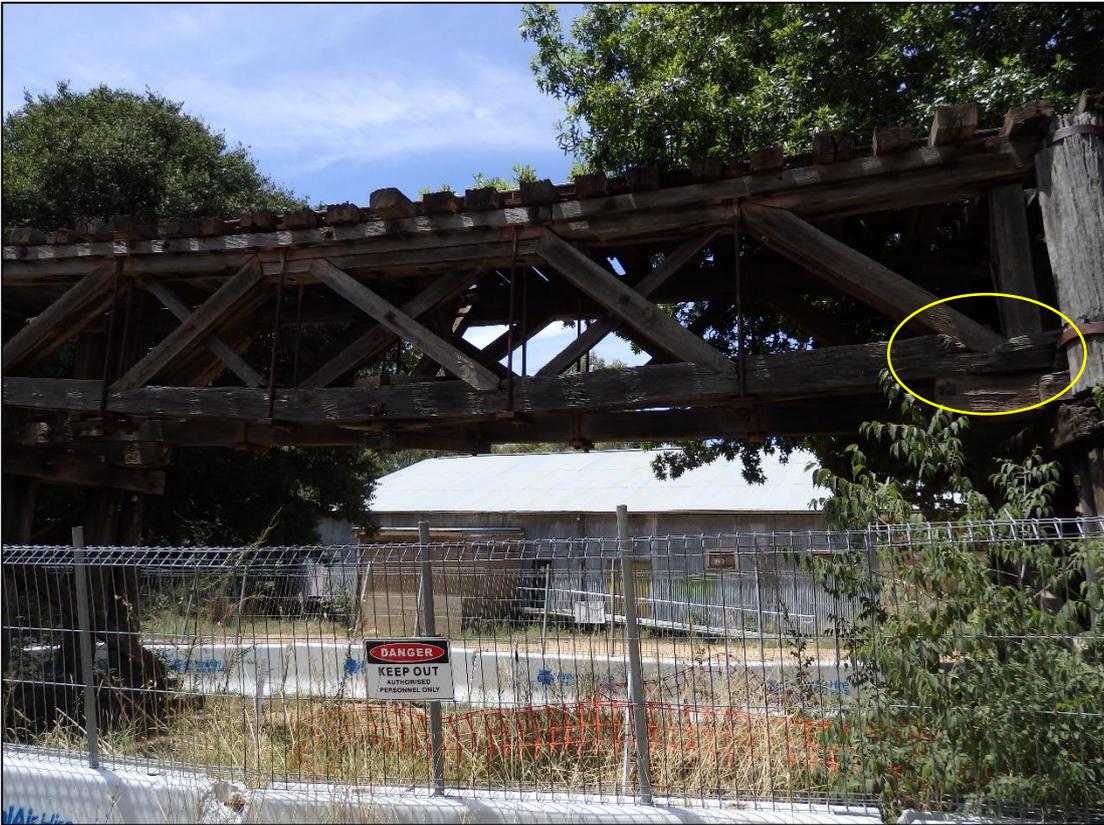
Plate 17 – Bottom Chord Crushed, Up Side Truss (near Trestle 78), Span 78

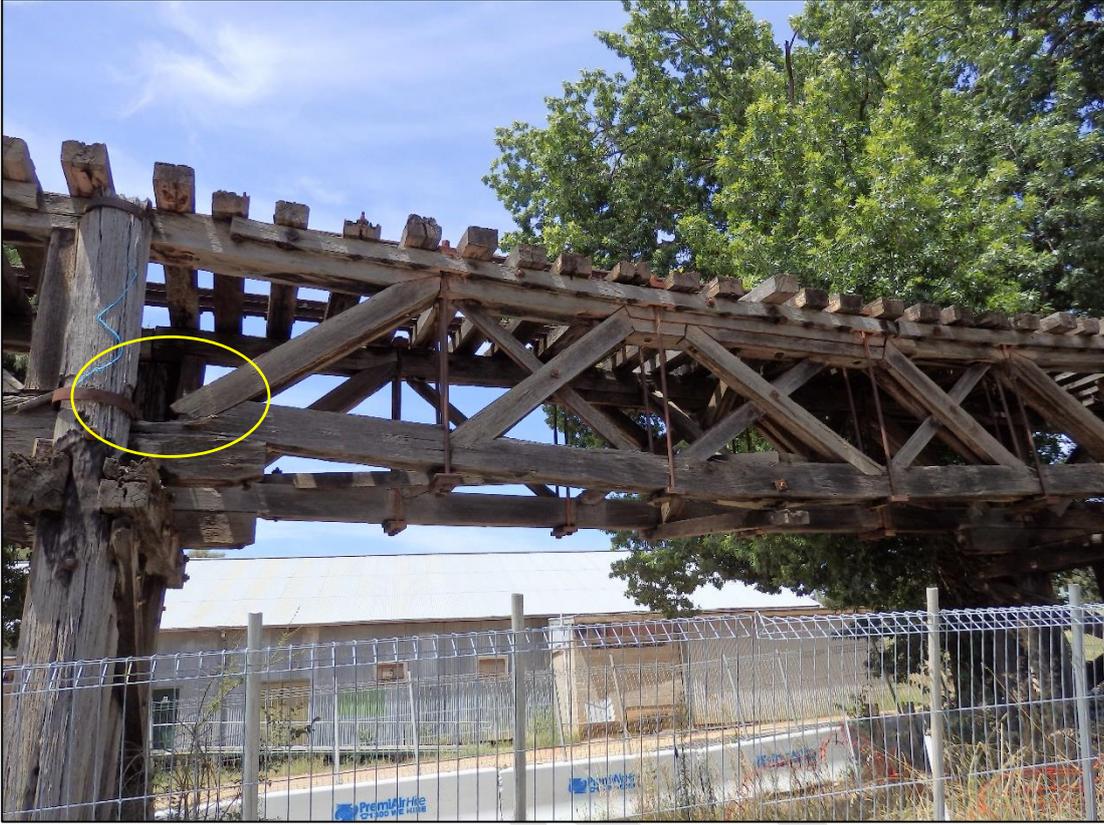
Plate 18 – Bottom Chord Decayed, Up Side Truss (near Trestle 77), Span 78

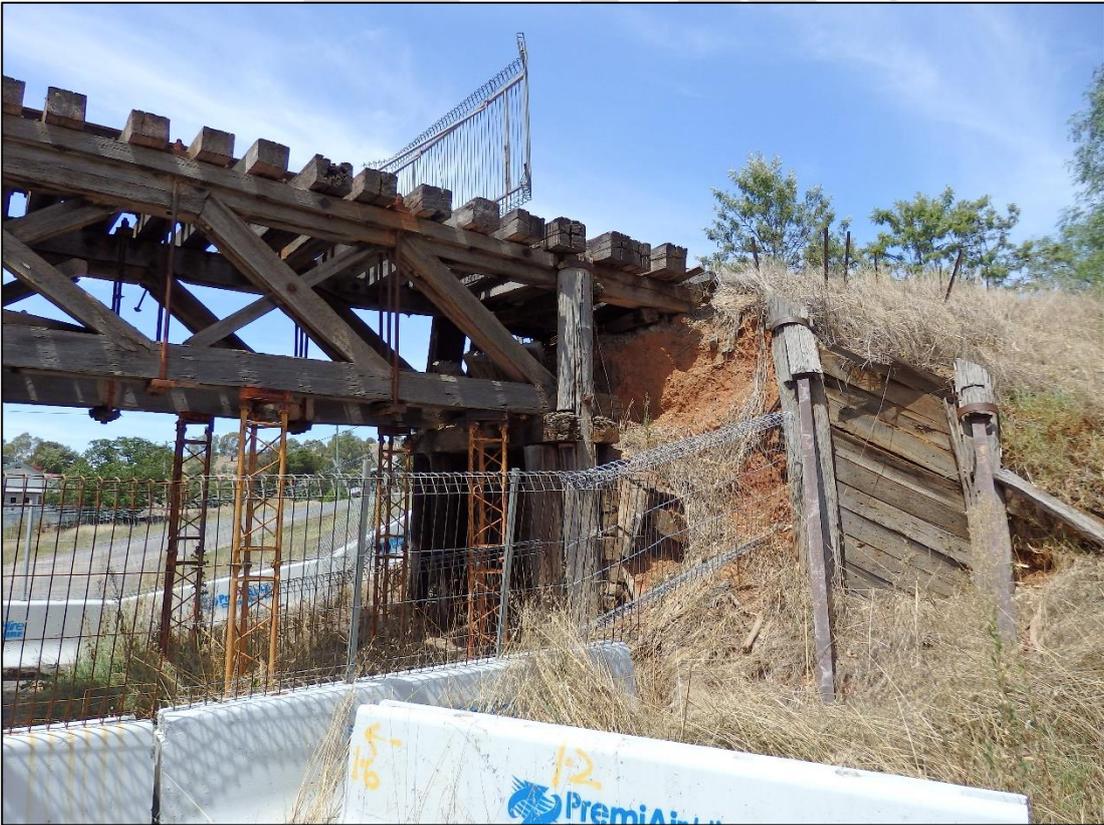
Plate 19 – Dilapidated Abutment 1
