GUNDAGAI RAILWAY BRIDGE AND VIADUCTS – CONVERSION TO RAIL TRAIL

Feasibility Report

01 MAY 2018

Report No F0001-10005572-NSR-01

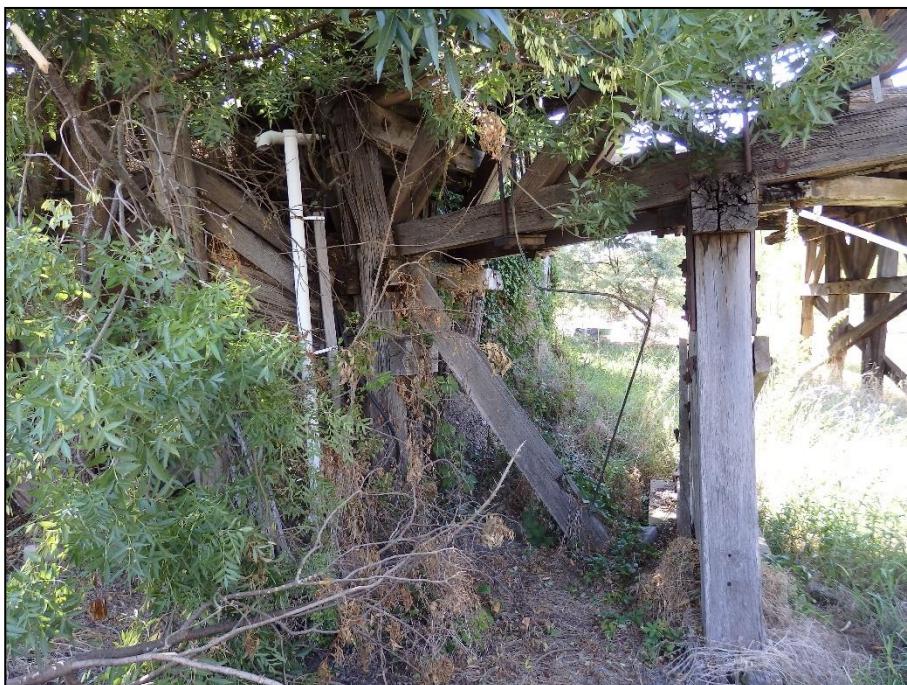
Sydney Abutment (February 2018):

- Sydney abutment (Abutment 1) dilapidated – In poor condition and is partially collapsed, piles broken, timber sheeting fractured. It is noted there is a supplementary timber trestle located close to the defective abutment, to provide additional support close to the end of the truss. Refer Plate 11, Appendix B.

The indicative cost estimate is based on replacing 30% of all timber pier trestle elements (including piles, cross-bracing, headstocks and walings) and replacing both timber abutments in their entirety.

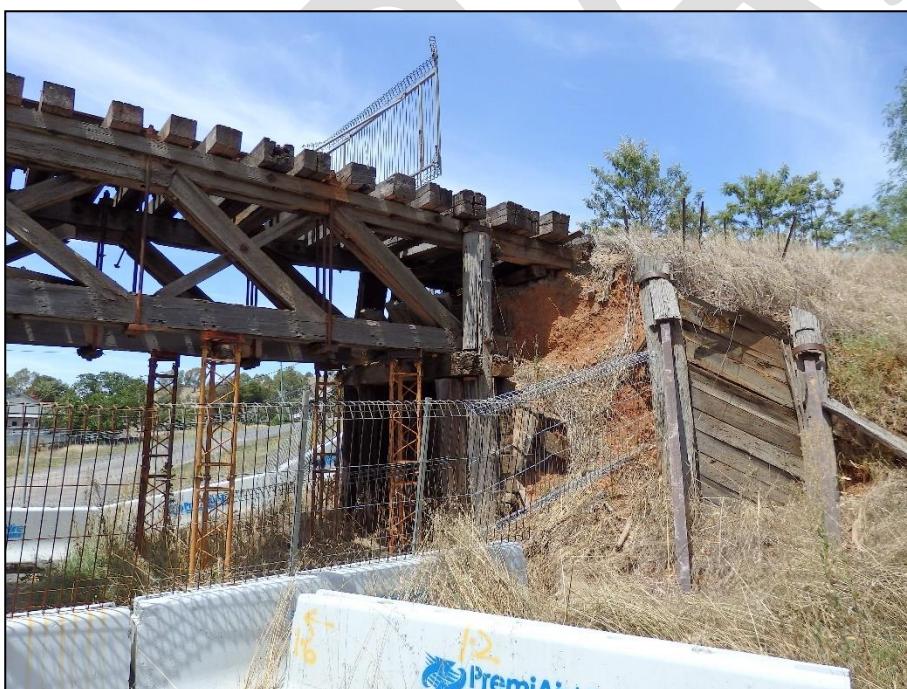
Country Abutment (February 2018):

- Country abutment (Abutment 2) dilapidated – In poor condition with dislodged and broken timber sheeting, embankment scoured out during 2012 flood.
- Abutment 2 – Headstock deteriorated at ends.

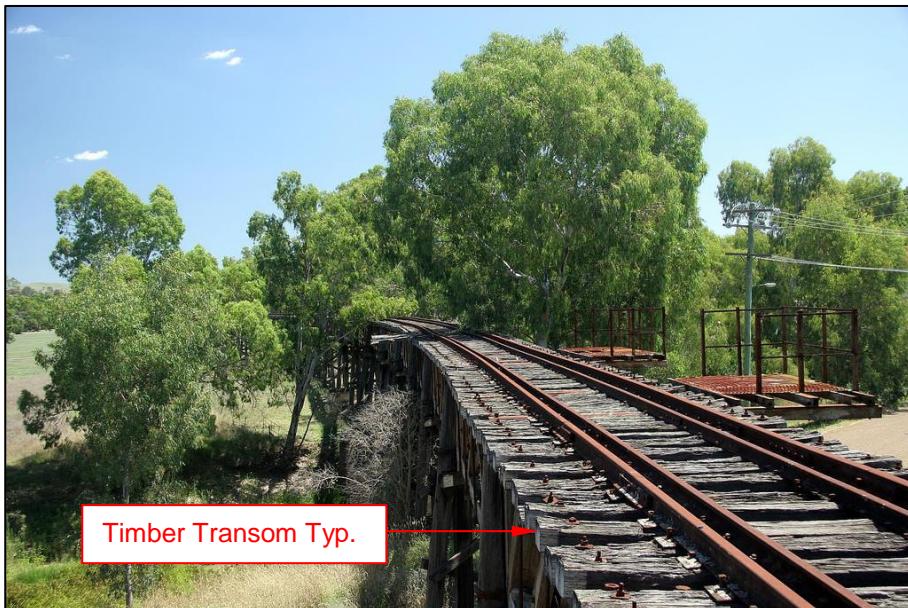
As the proposed shared path decking system will be supported by the timber transoms (larger version of sleepers), it is recommended that many of these be replaced, as they are very likely in deteriorated condition. As the overall length of the bridge and viaducts is approximately 925 metres, it is estimated that

The indicative cost estimate is based on replacing 50% of all timber transoms. Transoms are typically 250 mm W x 165 mm D x 2850 mm long.

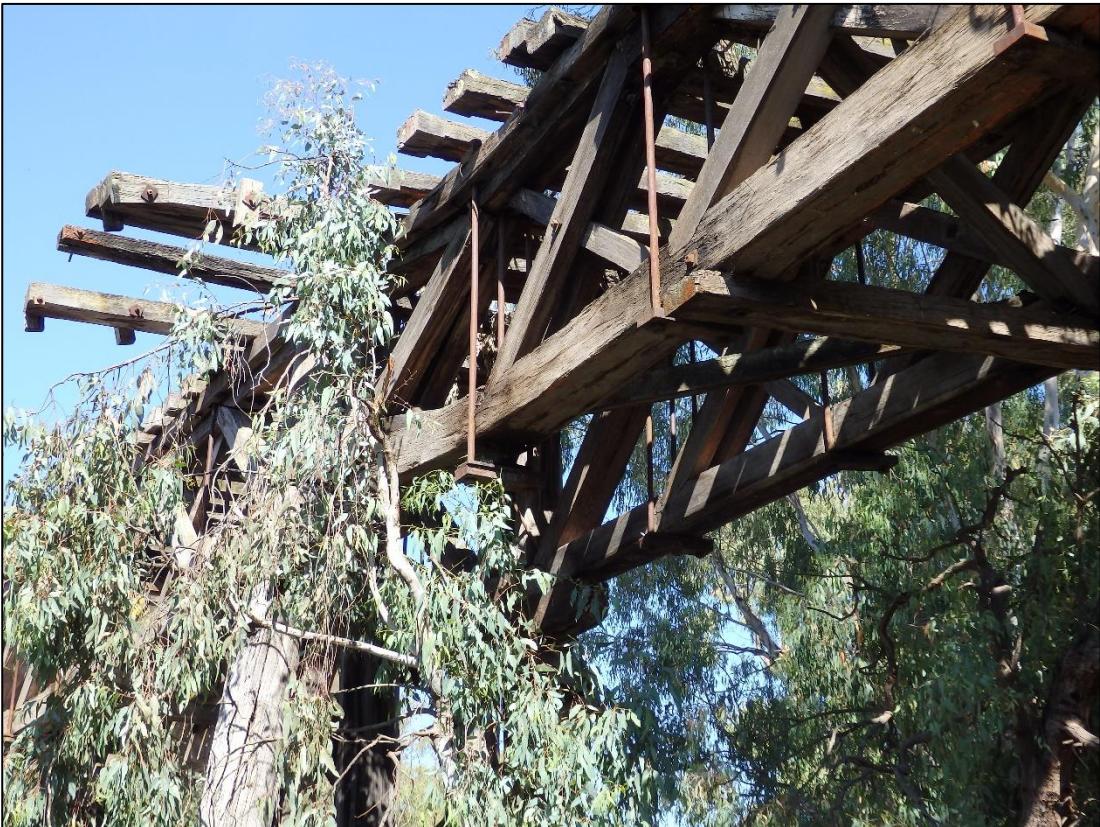
- Span 4 (Down side truss) – Top and bottom chord fractured (near Trestle 4). Refer Plate 1, Appendix B.
- Span 25 (Up side truss) – Top chord of 2nd panel and top chord of 4th panel severe decay (total loss of timber). Bottom chord weathered and split. Refer Plate 2, Appendix B.

Plate 1 – Fractured Top & Bottom Chords, Span 4, Down Side Truss (near Trestle 4)

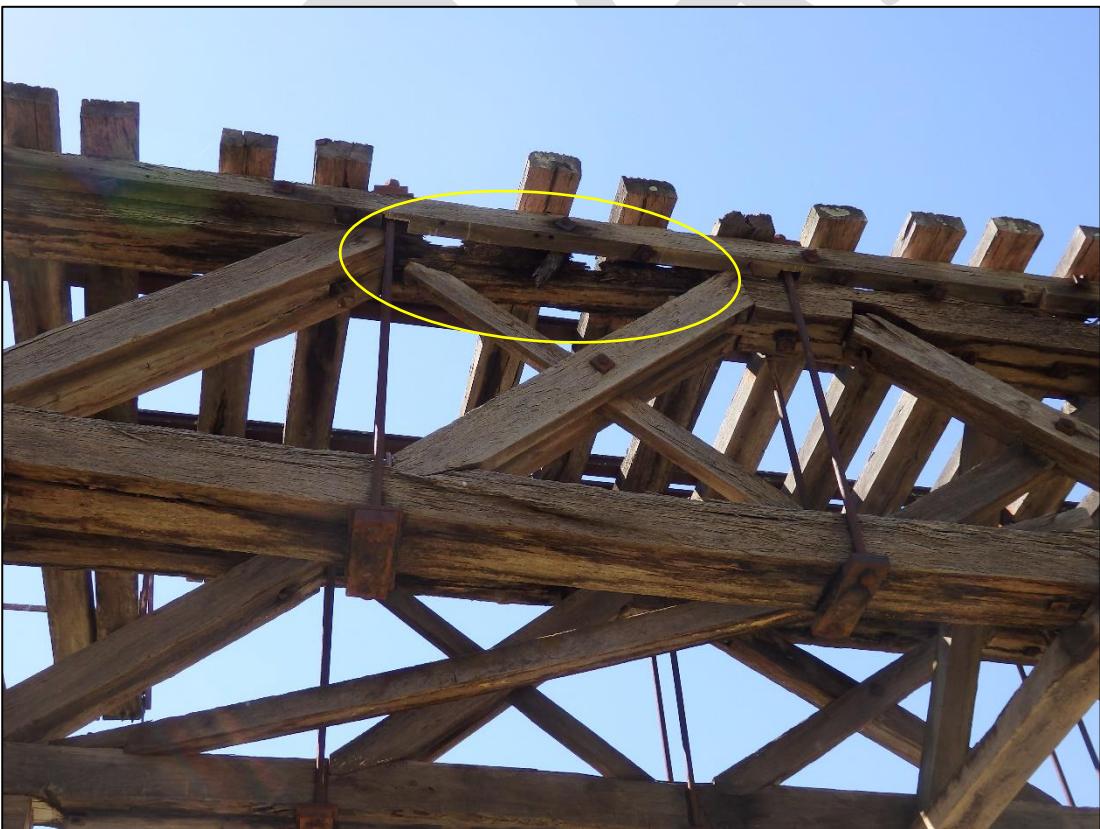
Plate 2 – Severe Decay at Top Chord, Span 25, Up Side Truss

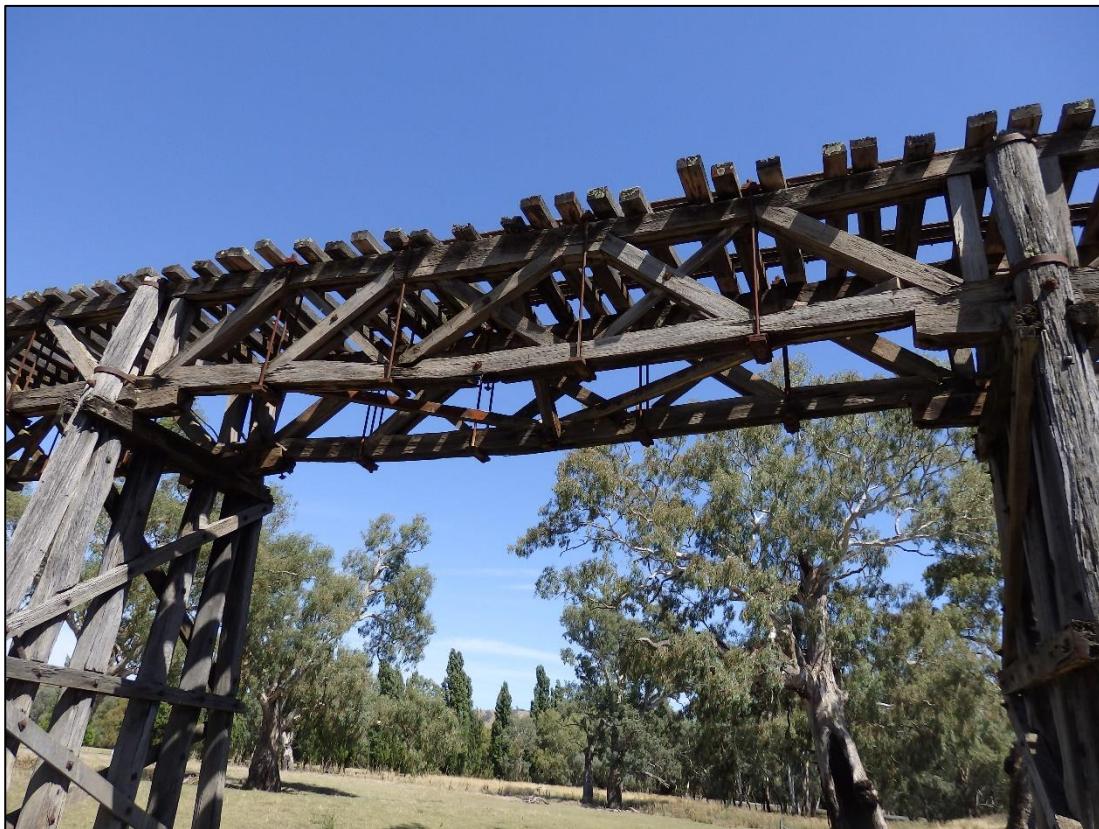
- Span 30 (Up side truss) – Severe decay of top chord at 4th panel point.
- Span 49 – Detached bottom chord cross beam.
- Span 51 – Total fracture of bottom chords of each truss (at mid-span). Refer Plate 3, Appendix B.
- Span 54 – Up side bottom chord decayed at interface with missing corbel (at Trestle 53). Bottom chord has dropped onto cap sill following loss of corbel. Refer Plate 4, Appendix B.
- Transoms severely weathered and split throughout length of viaducts and bridge spans. Also, transoms are ‘bunched up’ at a number of locations.

Plate 3 – Fractured Bottom Chord, Span 51, Up Side & Down Side Trusses

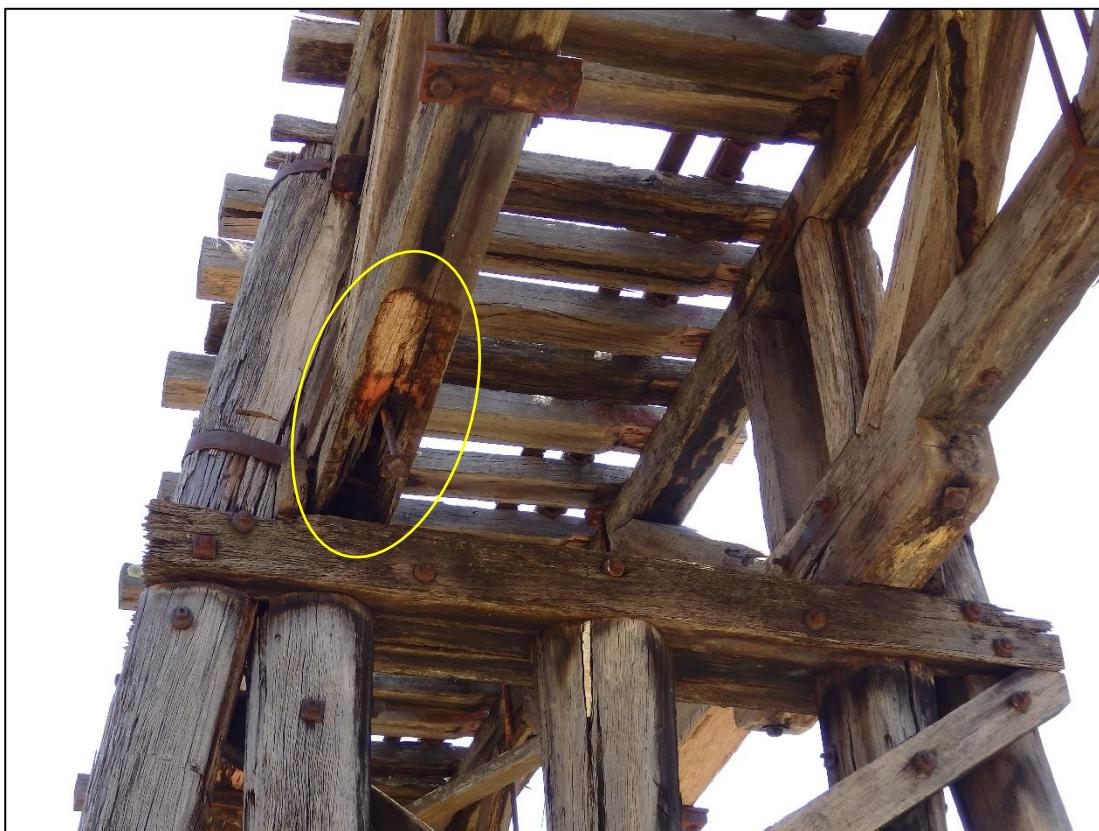
Plate 4 – Missing Corbel & Bottom Chord Decayed, Span 54 (at Trestle 53), Up Side Truss

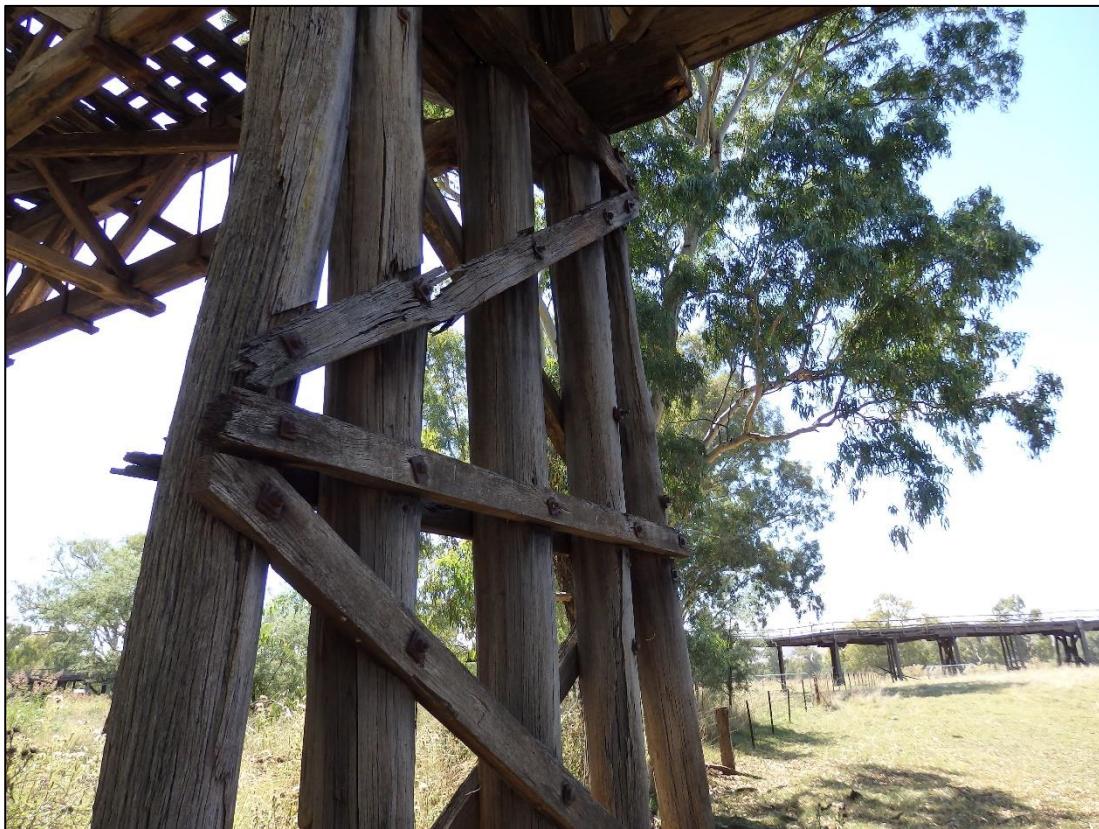
- Trestle 16 – Decayed bottom waling and decayed upper cross-bracing. Refer Plate 5, Appendix B.
- Trestles 17 to 22 (inclusive) – Decayed bottom walings. Refer Plate 6, Appendix B.

Plate 5 – Decayed Upper Cross-Bracing, Trestle 16

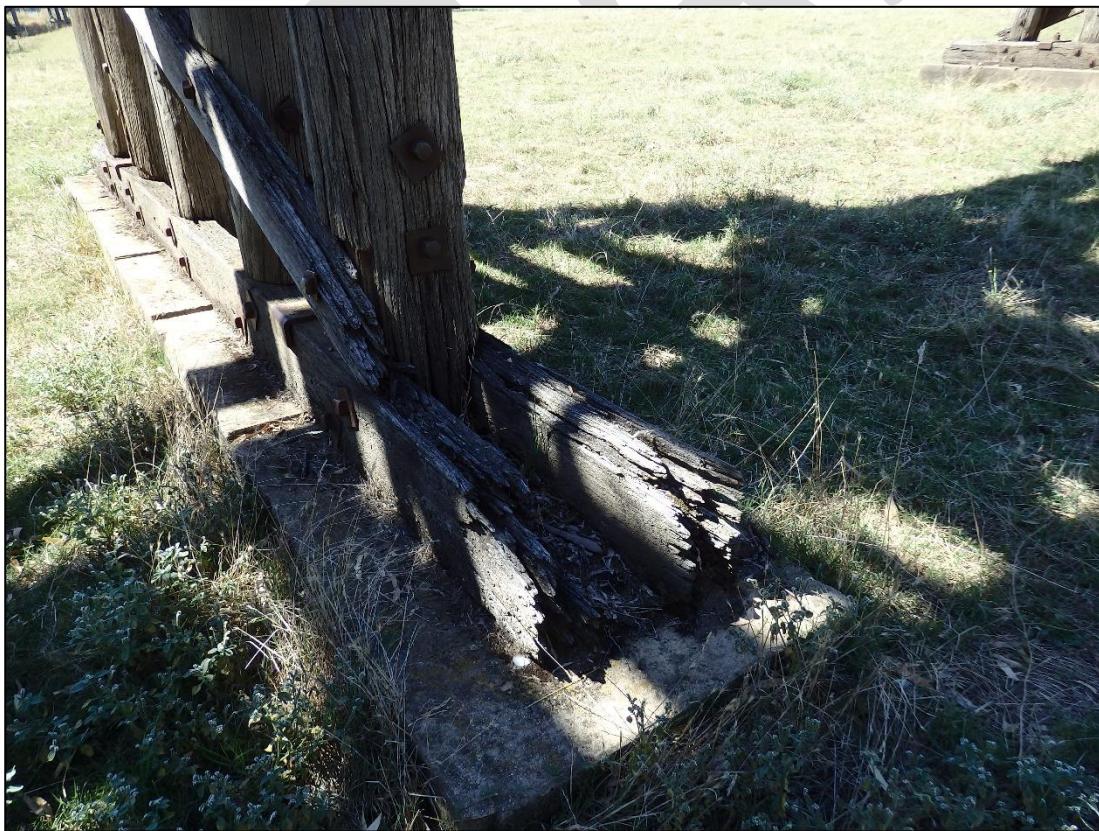
Plate 7 – Decayed Bottom Walings (Typical for Trestles 17 to 22 (inclusive))

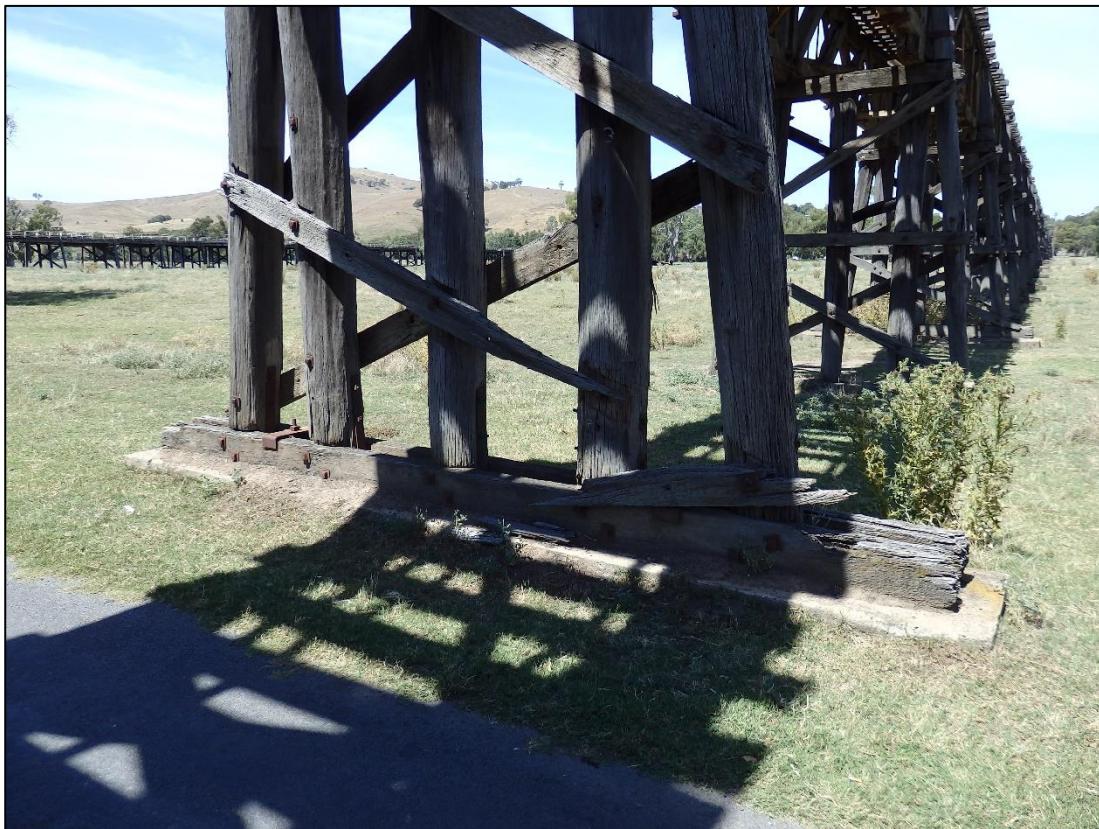
- Trestle 23 – Broken cross-bracing. Refer Plate 7, Appendix B.
- Trestle 24 – Severely weathered bottom walings. Cross-bracing broken (on one side).
- Trestle 26 – Severely deteriorated bottom waling. Refer Plate 8, Appendix B.

Plate 8 – Broken Lower Cross-Bracing, Trestle 23

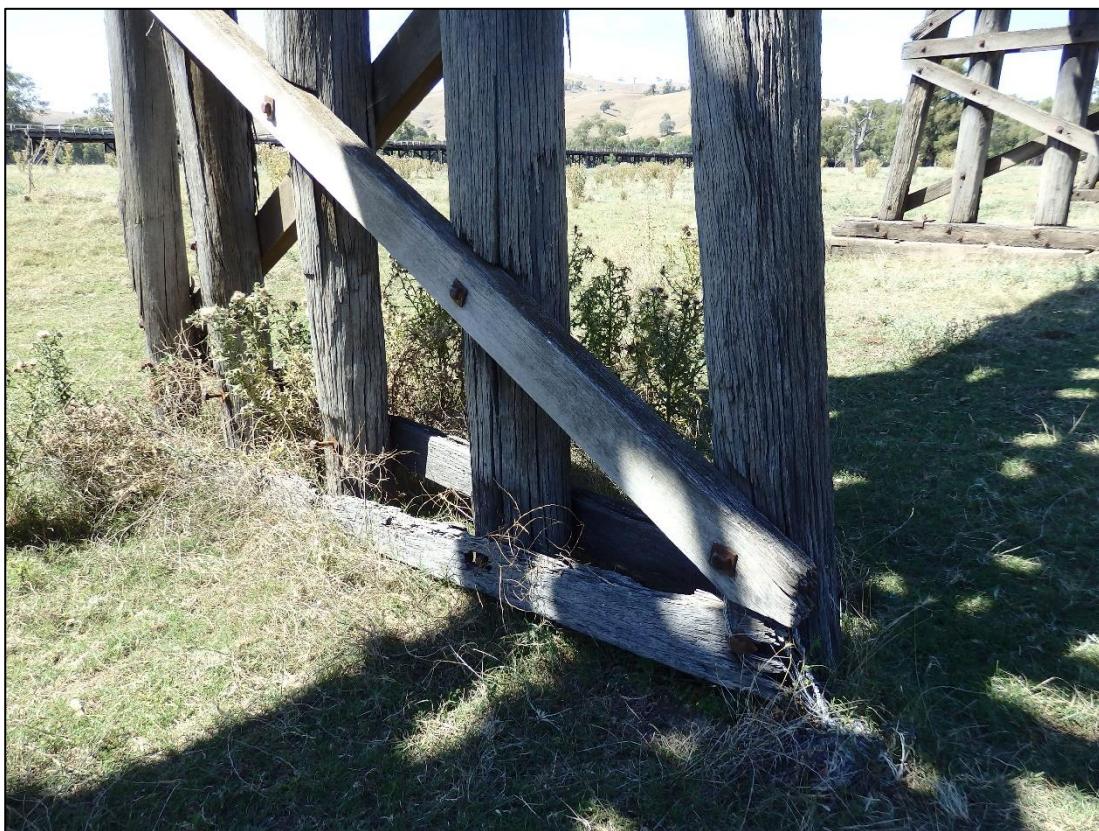
Plate 9 – Severely Deteriorated Bottom Waling, Trestle 26

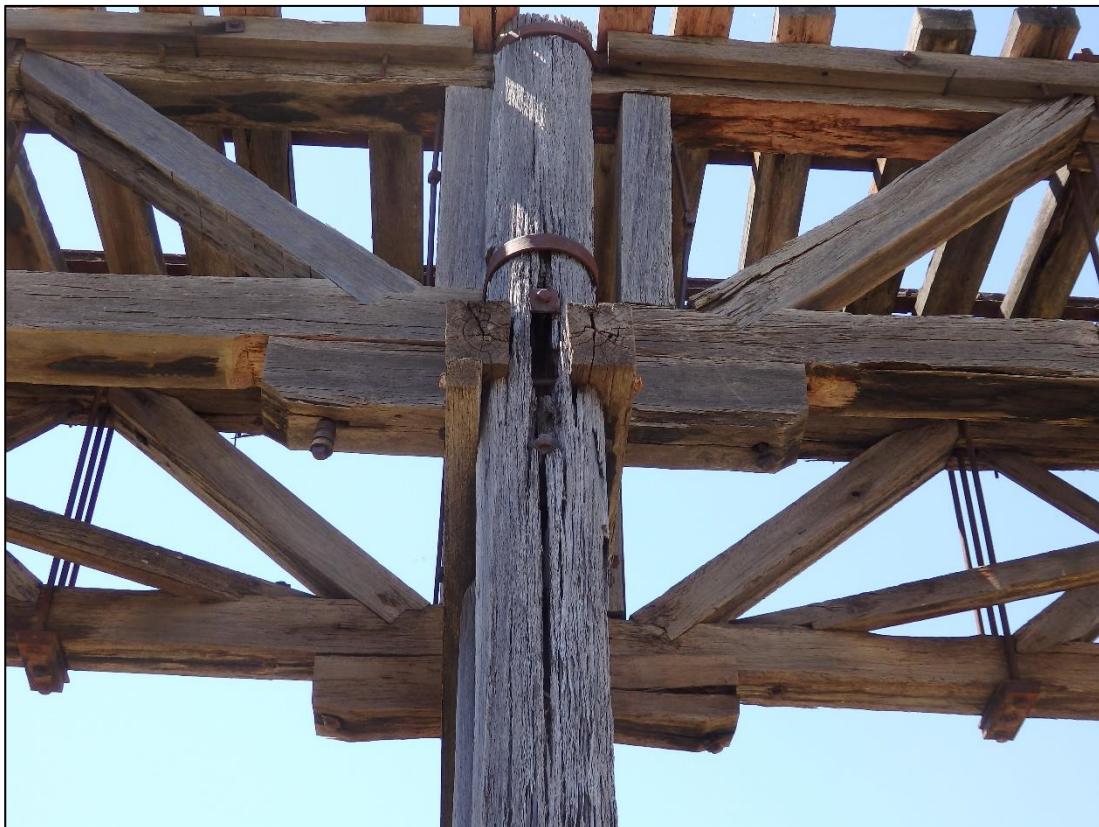
- Trestle 27 – Severely deteriorated/missing timber at bottom waling.
- Trestle 29 – Severely deteriorated bottom waling.
- Trestle 39 – Down side column has vertical split. Also, severe decay at top. Refer Plate 9, Appendix B.

Plate 10 – Split & Decay, Down Side Pile, Trestle 39

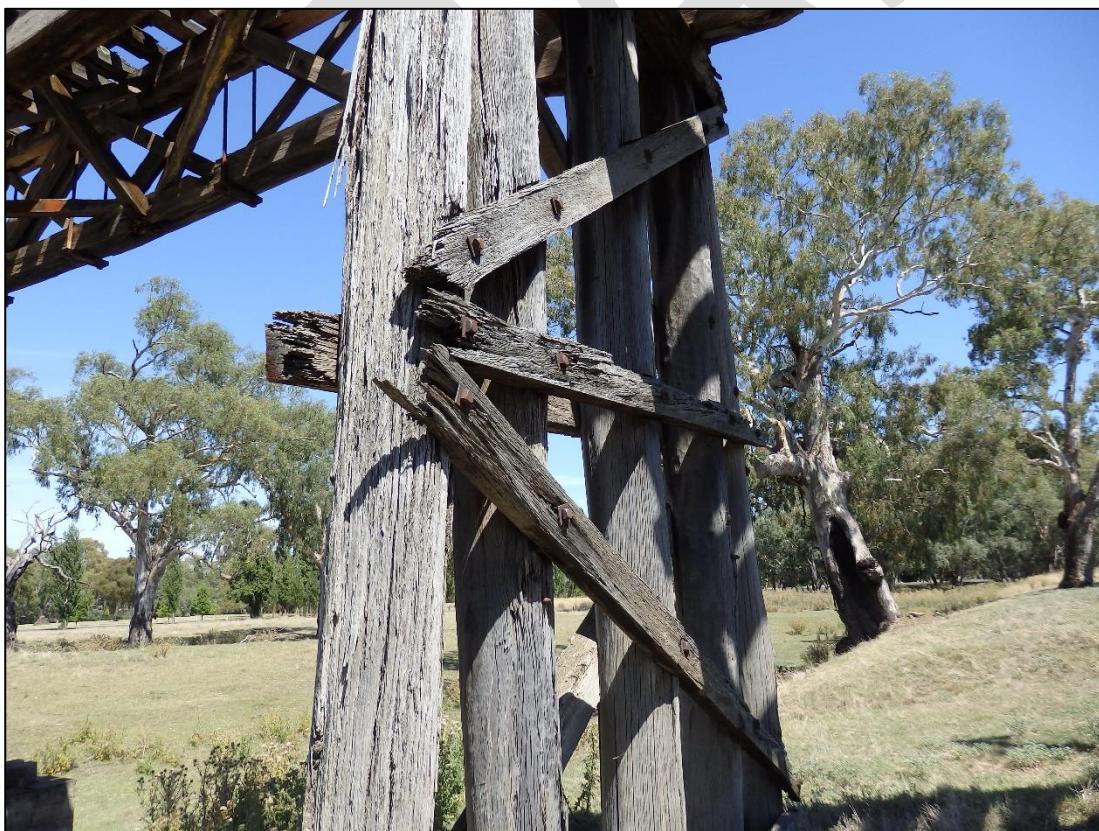
- Trestle 50 – Totally deteriorated bottom walings and severely deteriorated mid-height waling. Refer Plate 10, Appendix B.
- Trestle 54 – Cross-bracing cut. Mid-height waling decayed.

Plate 11 – Deteriorated Mid-Height Walings, Trestle 50

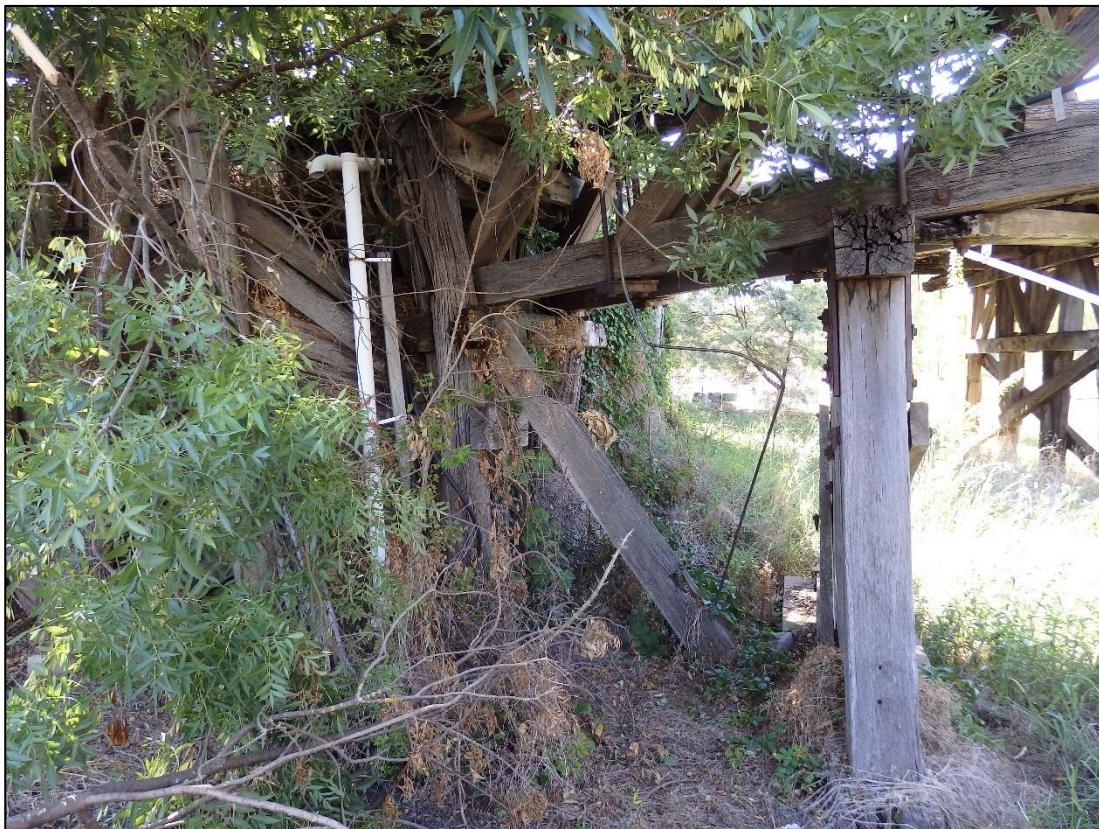
Plate 12 – Dilapidated Abutment 1

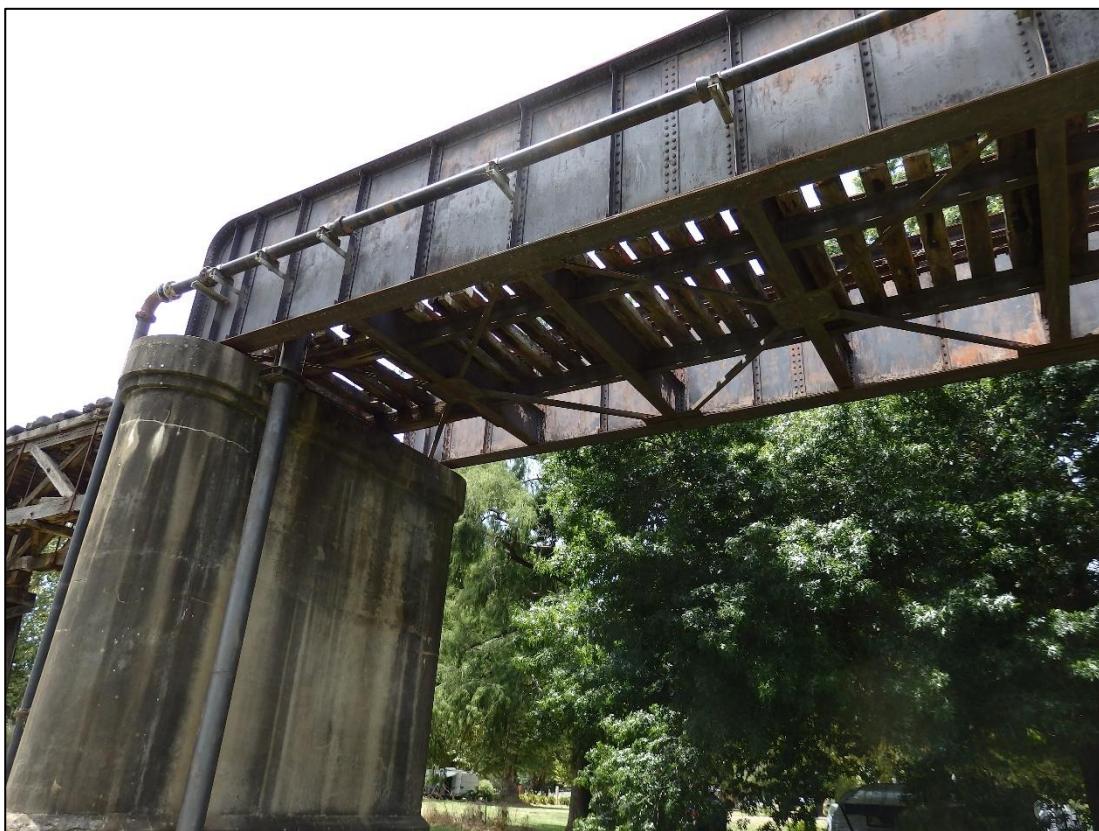
Plate 13 – Span 73

- Span 73 (half-through girder) – Steelwork appeared (from a distance) in fair to good condition, apart from loss of paintwork throughout and subsequent surface rust throughout. Refer Plate 12, Appendix B.
- Span 75 (half-through girder) – Steelwork appeared (from a distance) in fair to good condition, apart from loss of paintwork throughout and subsequent surface rust throughout. Refer Plate 14, Appendix B.

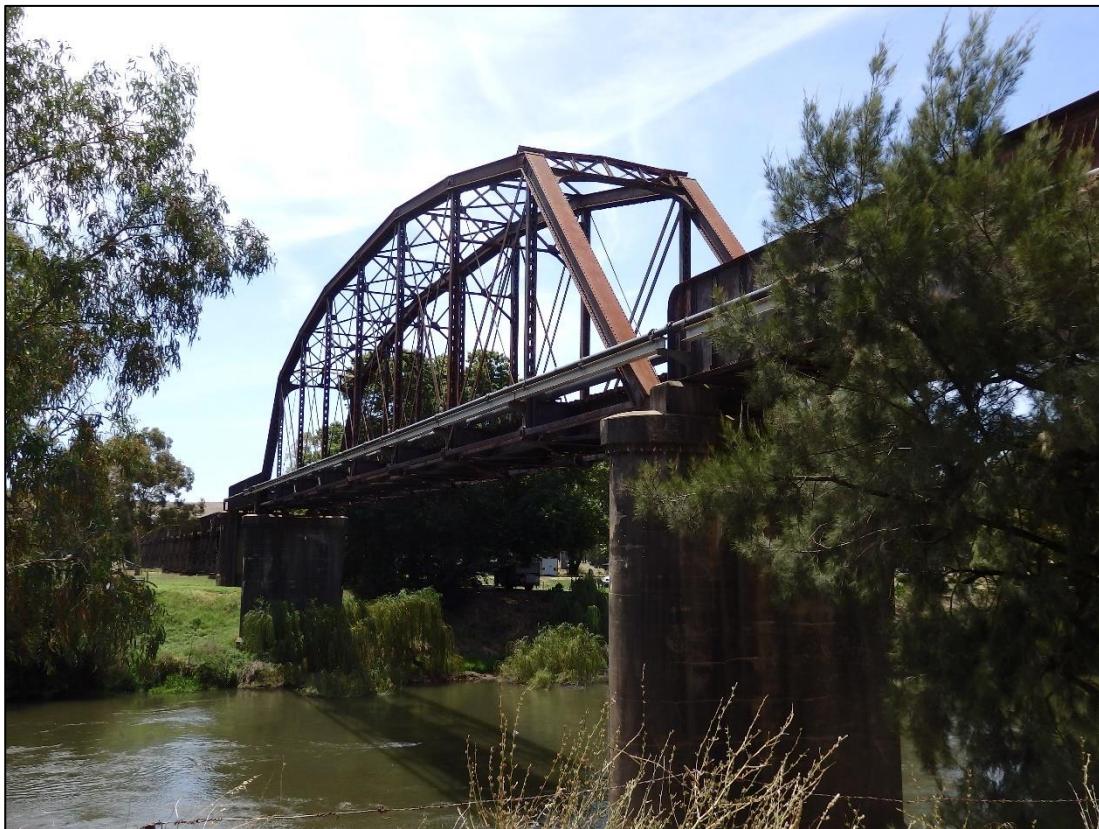
Plate 14 – Span 74

- Span 74 (truss) – Apart from loss of protective paintwork on all steel elements, and subsequent surface rust throughout, the steel truss span appeared (from a distance) to be in fair to good condition. Refer Plate 13, Appendix B.

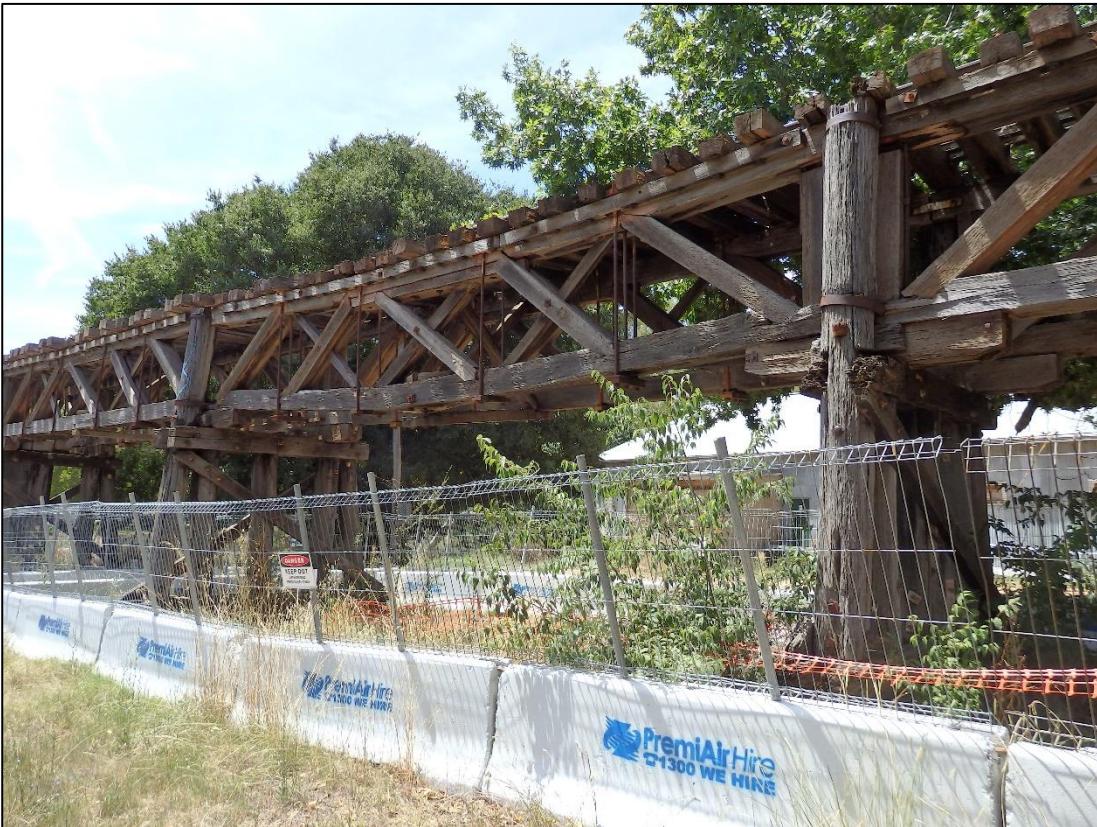
There is significant sag of the Up side truss of Span 78, which is the middle span of the five spans of the Southern Viaduct. It was noted that the Up side bottom chord truss end at Trestle 77 has decayed, resulting in dislodgement of the end post of the truss and disconnection with the bottom chord of the adjacent truss span, thereby causing it to sag, but still resting on the corbel. Essentially, the triangulated truss members have lost their ‘tightness’ and the entire truss has deflected like a beam element.

- Span 78 – Up side truss sagging.
- Span 78 – Up side bottom chord crushed (near Trestle 78).
- Span 78 – Up side bottom chord entirely decayed locally (near Trestle 77).

Plate 16 – Sagging Up Side Truss, Span 78

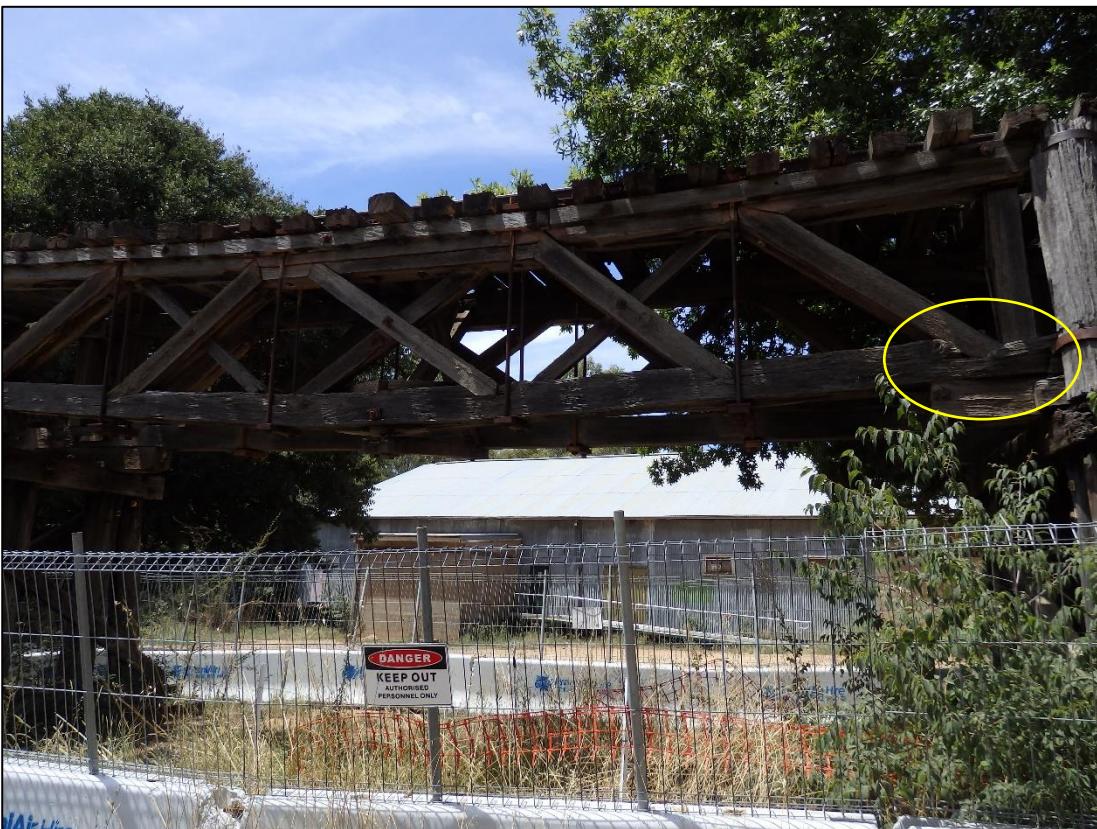
Plate 17 – Bottom Chord Crushed, Up Side Truss (near Trestle 78), Span 78

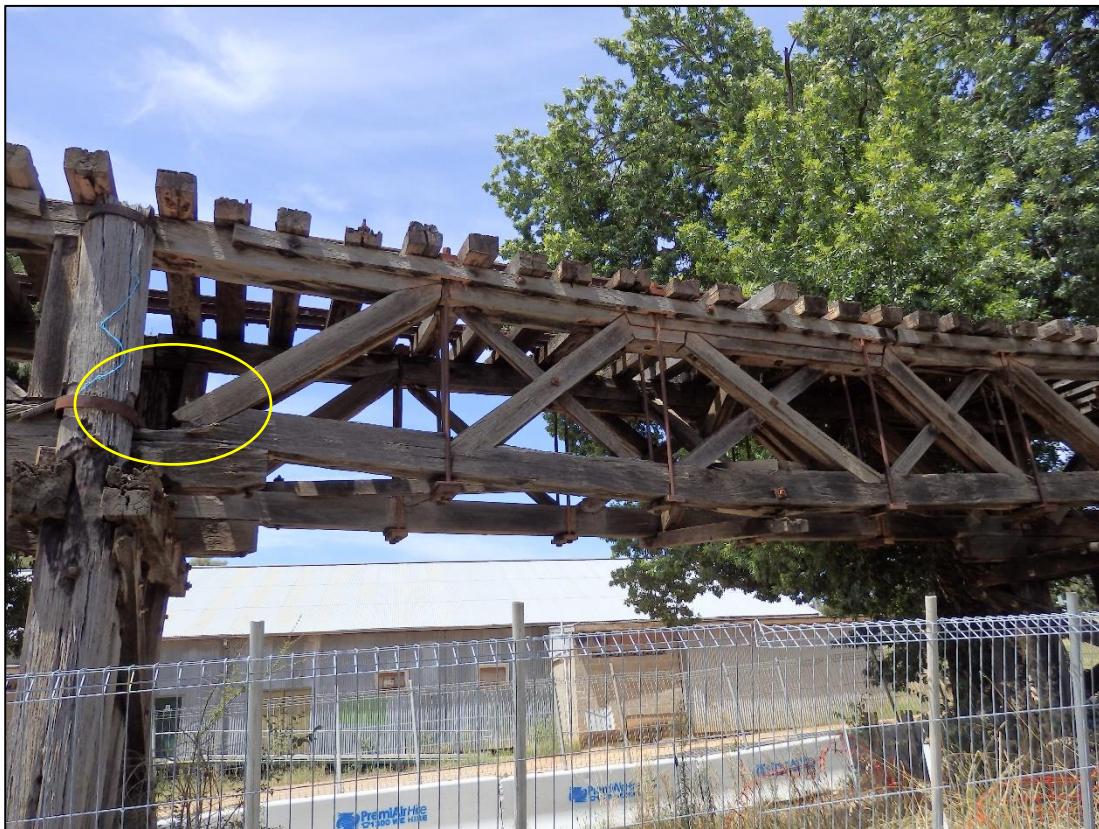
Plate 18 – Bottom Chord Decayed, Up Side Truss (near Trestle 77), Span 78

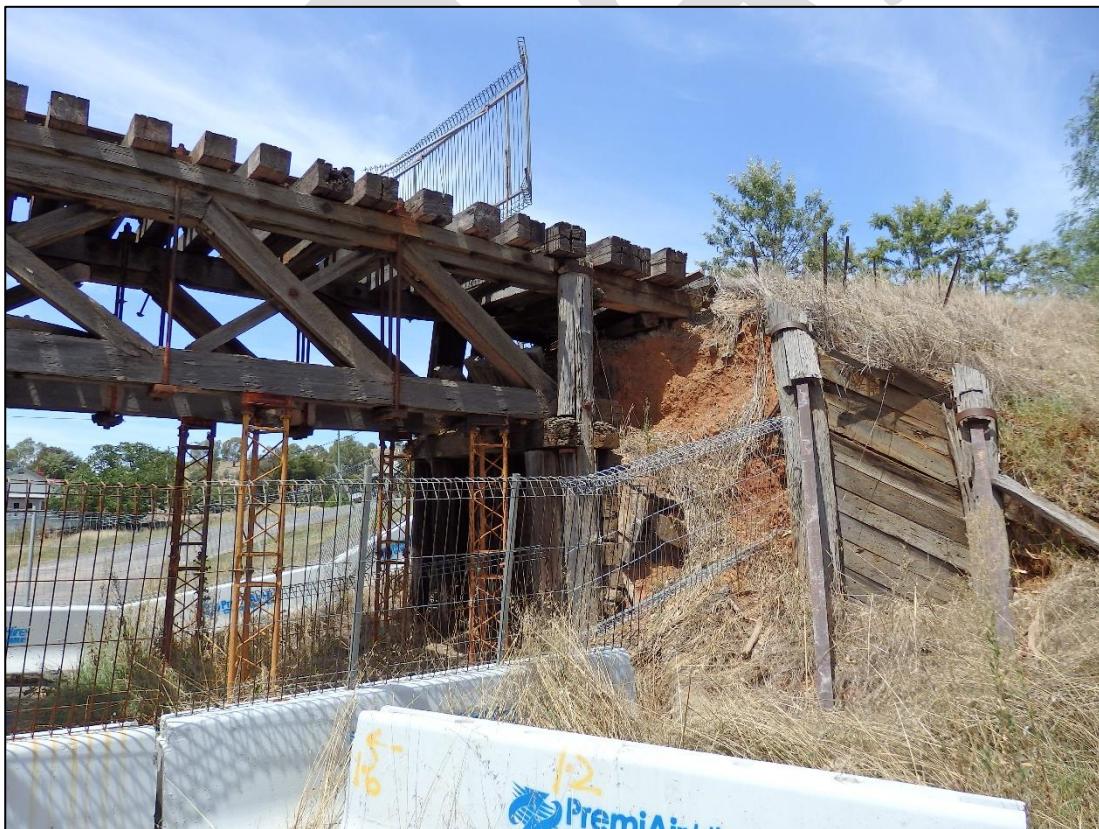
Plate 19 – Dilapidated Abutment 1
