COOTAMUNDRA FLOOD STUDY

DRAFT FOR PUBLIC EXHIBITION

Project Cootamundra Flood Study	Project Number 119039
Client Cootamundra-Gundagai Regional Council	Client's Representative Mike Brearley
Project Manager Erin Askew

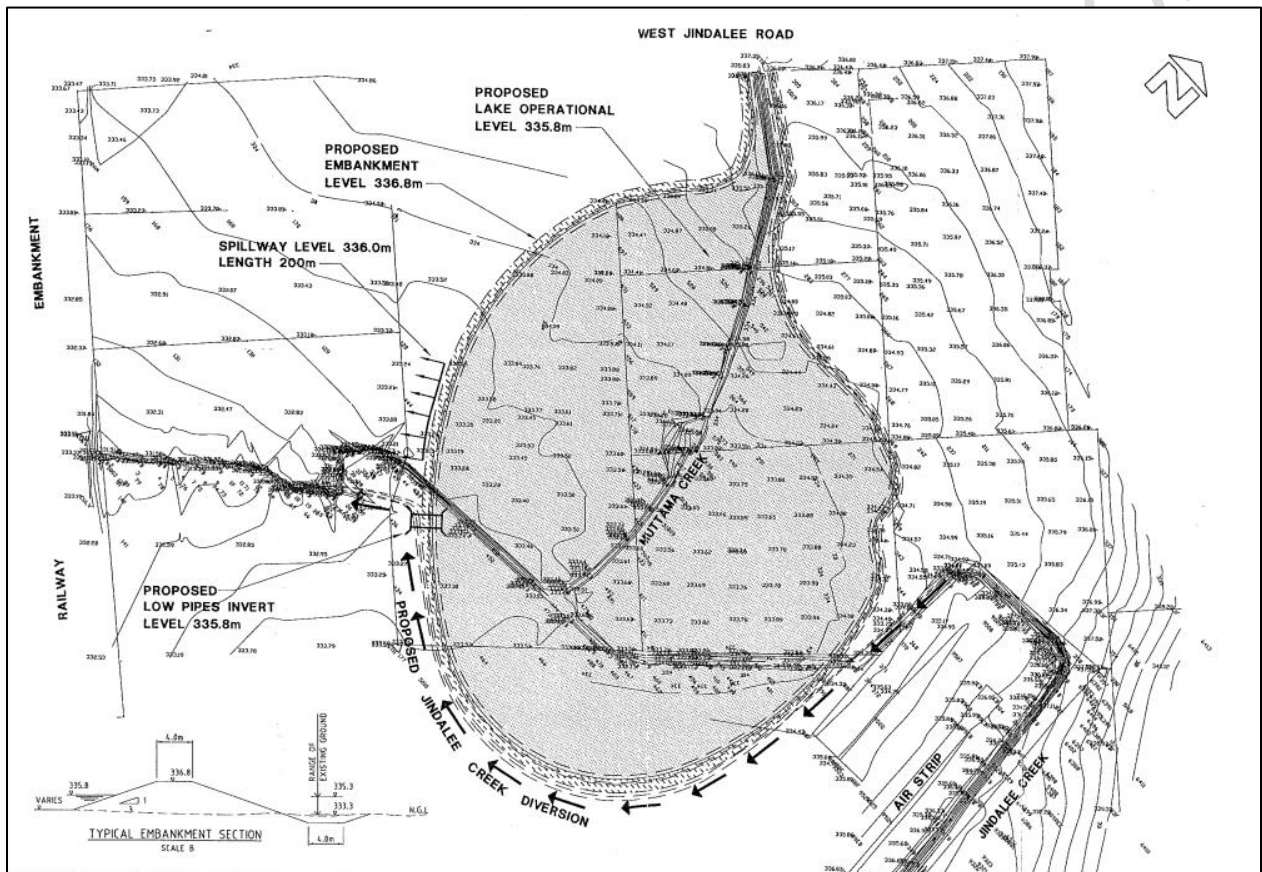
Diagram 1 Proposed Layout - Muttama Creek Lake (Fig B1 Reference 6)

The installation of such a lake would increase flood levels by 1.5 m at the lake inlet, extending approximately 1 km upstream of the lake, where water levels return to existing levels. Jindalee Creek would be diverted to the south to allow for the construction of the lake embankment. This would increase flood levels in the vicinity of the aerodrome from the Muttama/Jindalee Creek confluence. However, the report noted that 'the construction of the proposed lake upstream of town decreases flood levels in the township marginally'

The proposed lake layout is shown in Diagram 1. It is noted that at the time of writing, the lake and embankments had not been constructed.

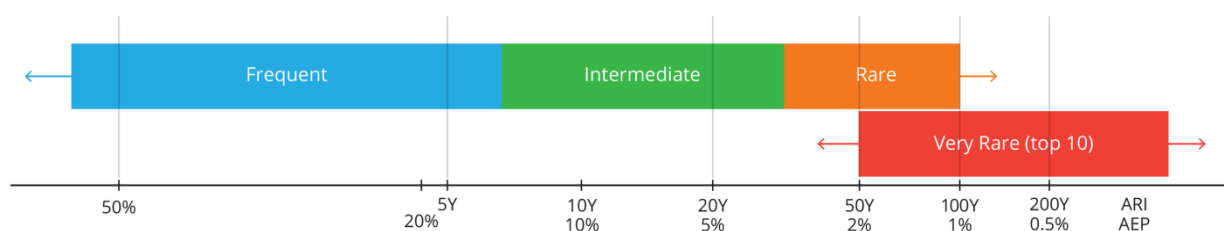
Diagram 2: Temporal Pattern Bins

The ARR 2019 method divides Australia into 12 temporal pattern regions, with the study catchment falling within the Murray-Darling Basin region. ARR 2019 provides 30 patterns for each duration, which are sub-divided into three temporal pattern bins based on the frequency of the events. Diagram 2 shows the three categories of bins (frequent, intermediate and rare) and corresponding AEP groups. The “very rare” bin is in the experimental stage and was not used in this flood study.

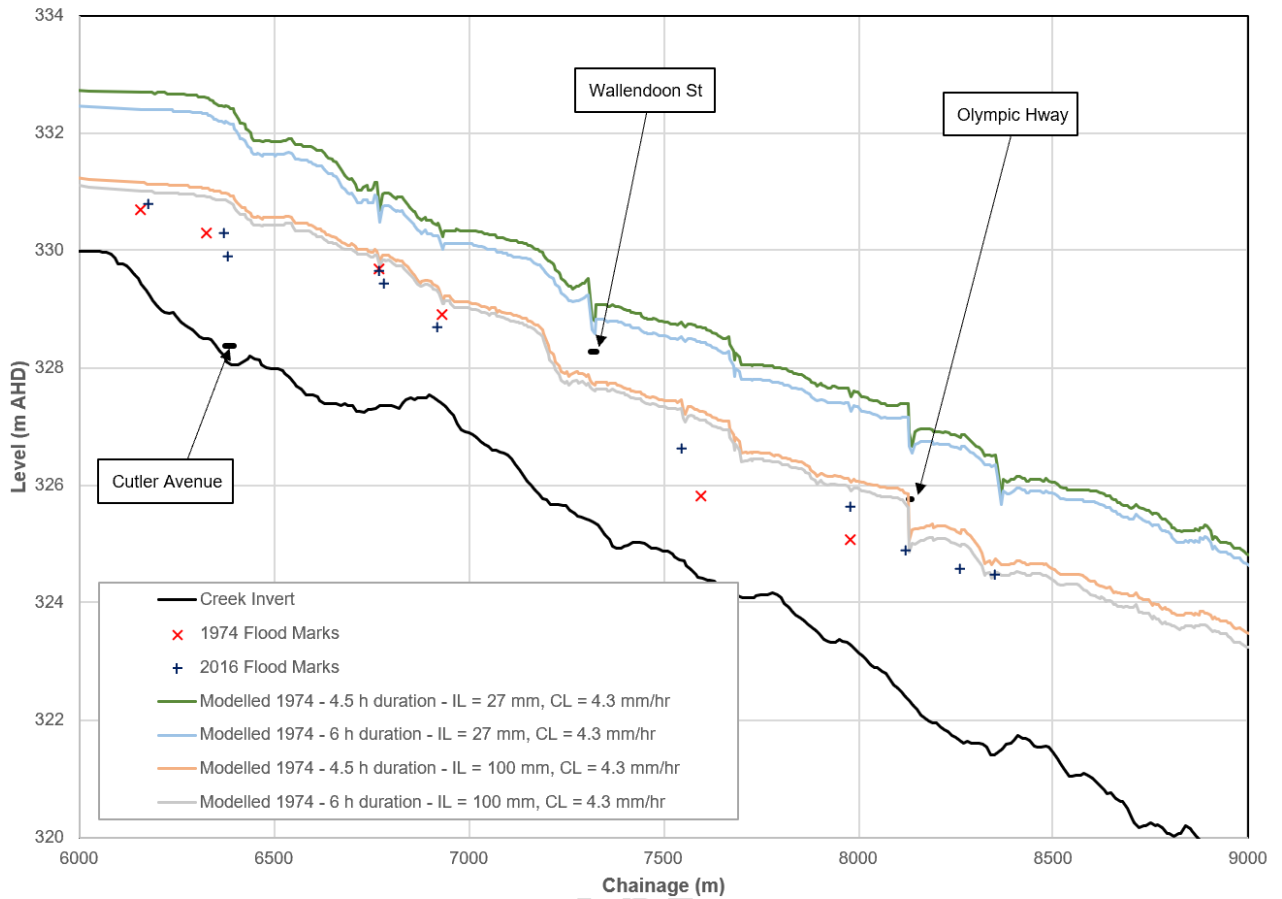
Diagram 3 Muttama Creek Long Section 1974 Event

The model representation of the 1974 event has significant uncertainty across a range of the inputs, including possible catchment changes, the spatial and temporal distribution of the storm event and the uncertainty regarding the flood mark estimates particularly downstream of Wallendoon Street. This uncertainty translates through to the modelled flood behaviour.

The uncertainty associated with the available data for the 1974 event means that it cannot be used to directly inform hydrologic and hydraulic model parameters, however it is useful to confirm that broadly the hydrologic and hydraulic models can generally reproduce observed flood behaviour with reasonable assumptions in the selection of model parameters. In addition the assessment of the 1974 event has confirmed that a continuing loss of 4.3mm/hr is reasonable for the catchment.

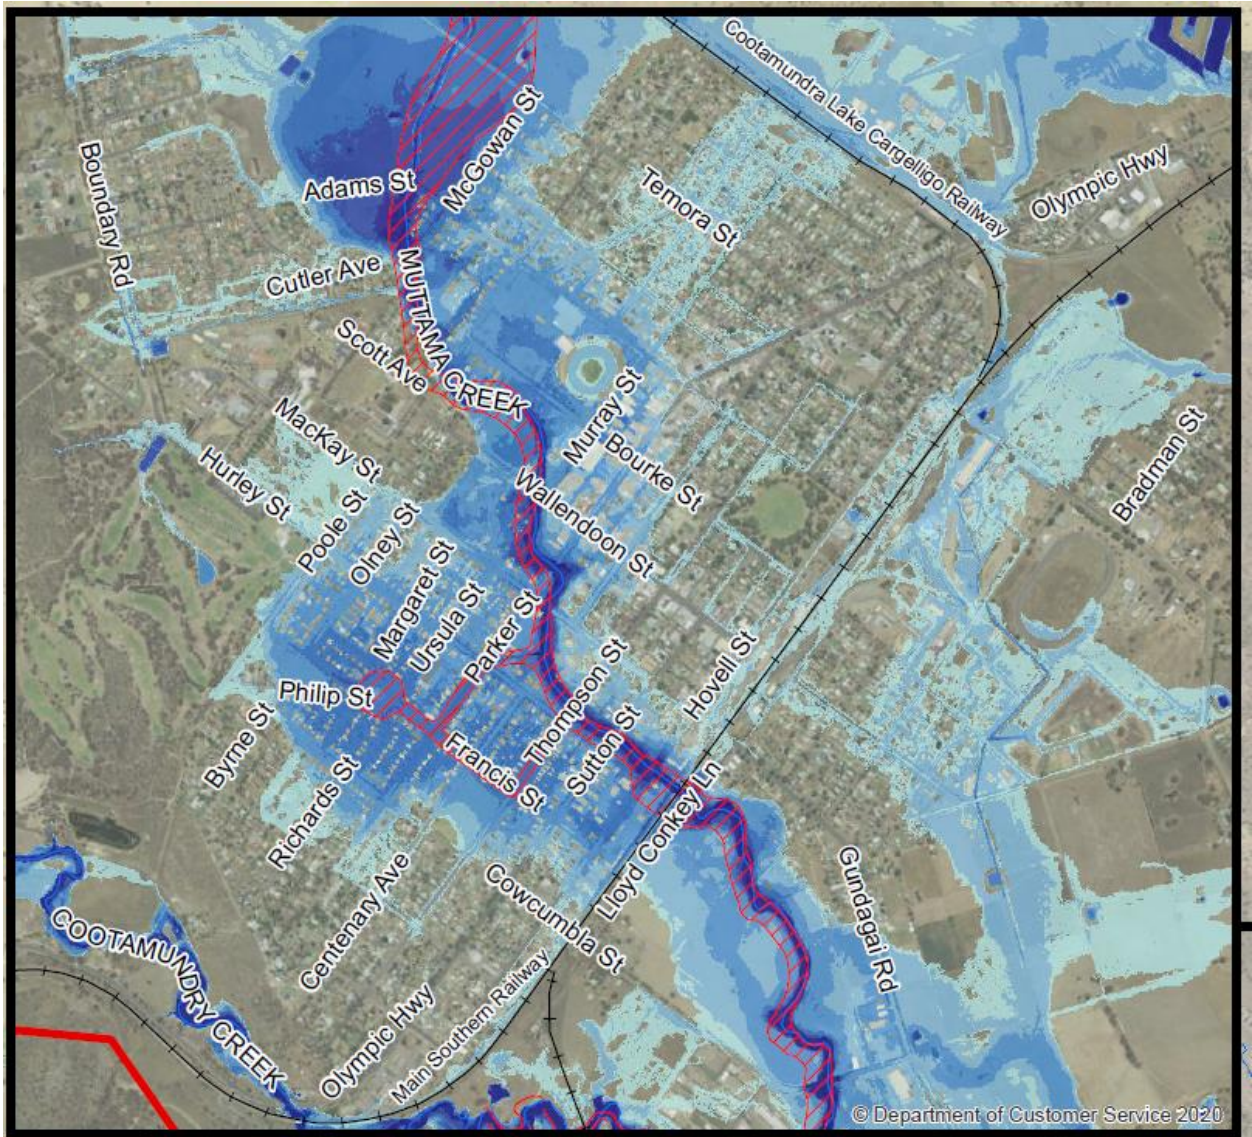
Diagram 4: Comparison of 1% AEP Flood Extent

The 1% AEP flood extent currently adopted by Council is based on a flow estimate of approximately 130m³/s and has been defined using a 1D hydraulic model; which does not allow a representation of flood behaviour beyond the channel and particularly in areas subject to overland flow. A comparison of the previous flood extent with that derived from the current study is provided in Diagram 4.

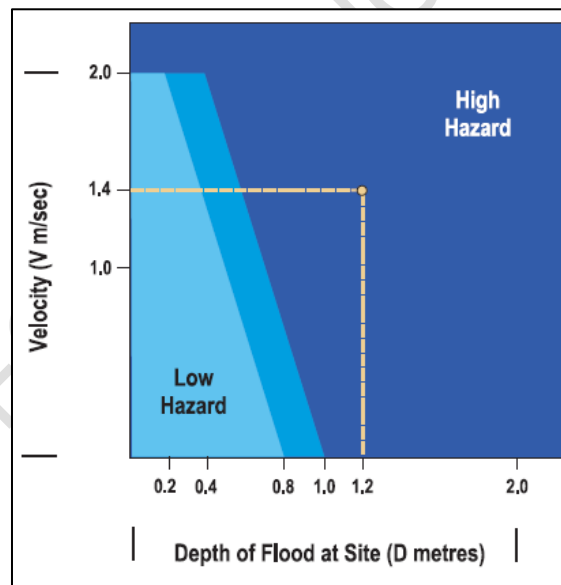
Diagram 5: "L2" Hydraulic Hazard Categories (FDM)

Appendix L of the NSW Floodplain Development Manual (FDM, Reference 2) gives one method for hydraulic hazard, which is shown in Diagram 5. In this study, the transition zone was considered to be high hazard.

The hydraulic hazard utilising the FDM categorisation is mapped on Figure 55 to Figure 57 for the 5% AEP, 1% AEP, 0.2% AEP and PMF events. The FDM hazard categorisation has been included for applicability to existing council policy documents that may refer to this hazard classification.

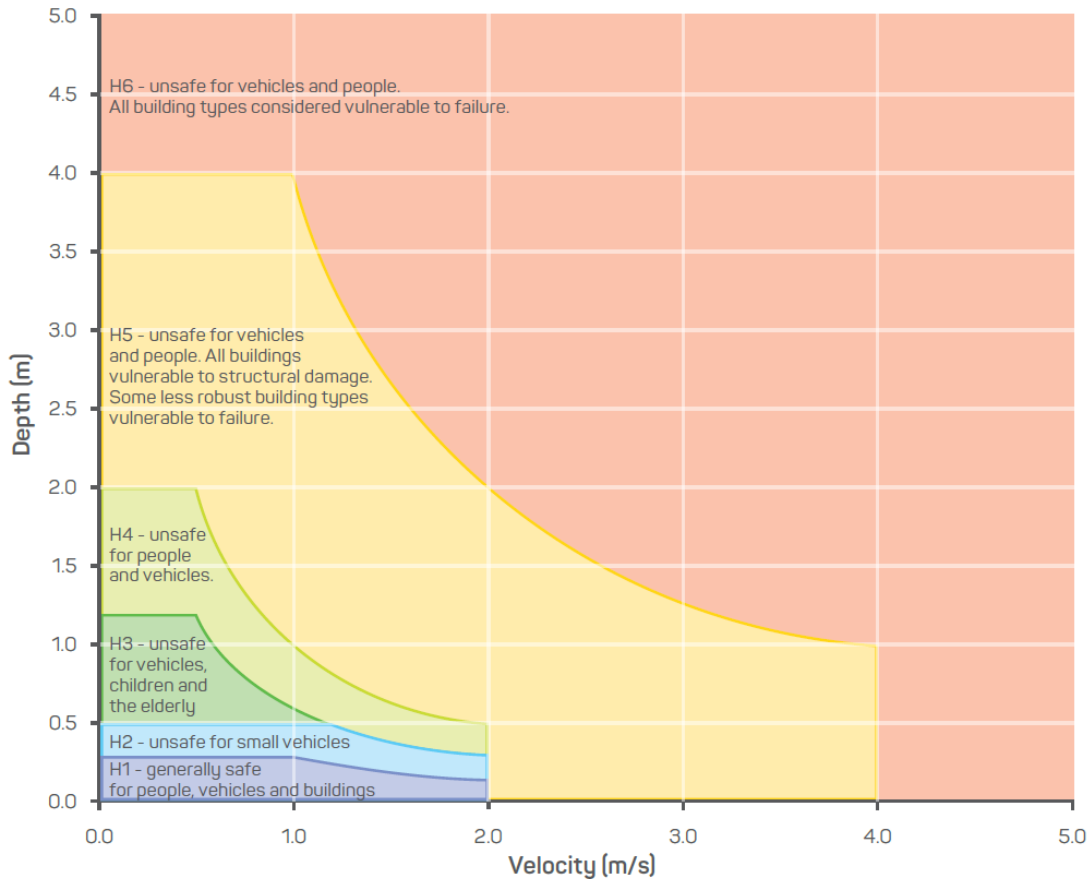
Diagram 6: General flood hazard vulnerability curves (ADR)

The Australian Disaster Resilience Handbook Collection deals with floods in Handbook 7 (Managing the Floodplain: A Guide to Best Practice in Flood Risk Management in Australia). The supporting guideline 7-3 (Reference 24) contains information relating to the categorisation of flood hazard. A summary of this categorisation is provided in Diagram 6.

This classification provides a more detailed distinction and practical application of hazard categories, identifying the following 6 classes of hazard:

- H1 – No constraints, generally safe for vehicles, people and buildings;
- H2 – Unsafe for small vehicles;
- H3 – Unsafe for all vehicles, children and the elderly;
- H4 – Unsafe for all people and all vehicles;
- H5 – Unsafe for all people and all vehicles. All building types vulnerable to structural damage. Some less robust building types vulnerable to failure. Buildings require special engineering design and construction; and
- H6 – Unsafe for all people and all vehicles. All building types considered vulnerable to failure.

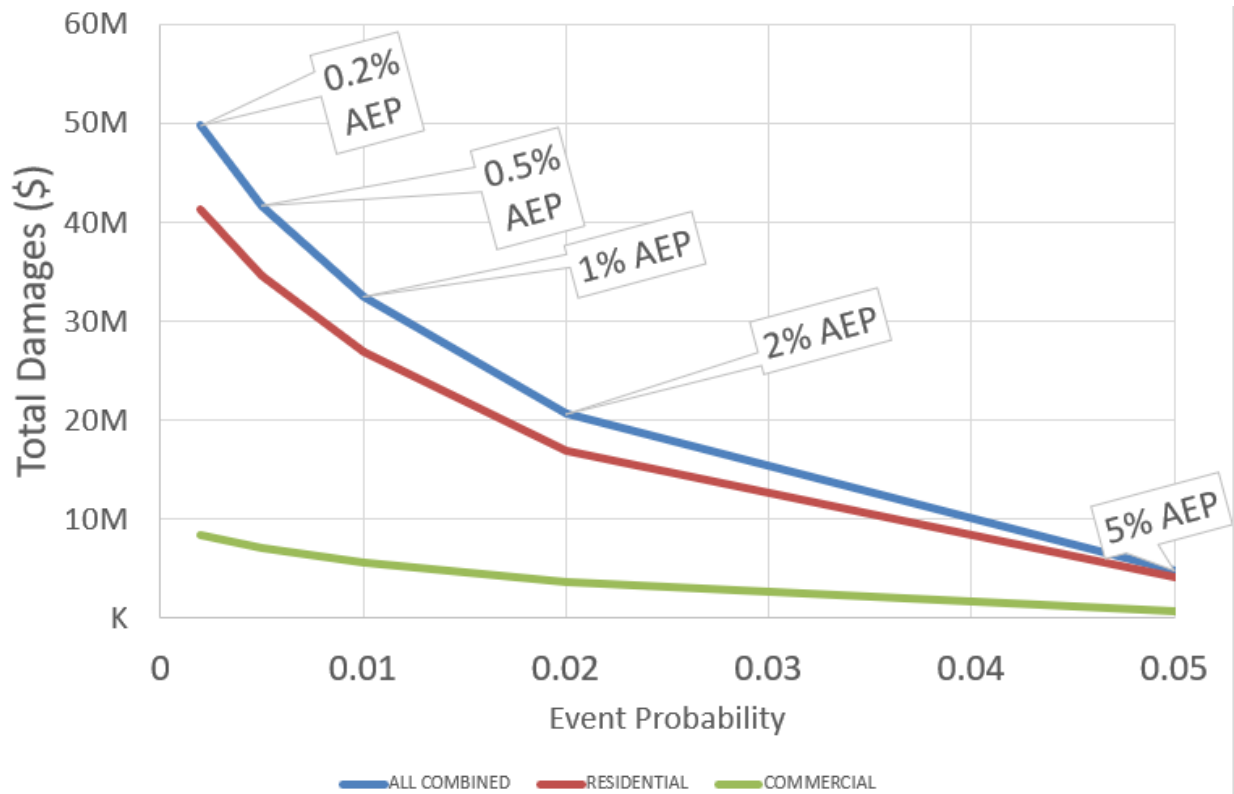
Chart 1 Total Flood Damages

Damages were calculated for residential and non-residential properties separately as discussed in the following sections.
