**COOTAMUNDRA-
GUNDAGAI REGIONAL
COUNCIL**

Gundagai Sewage Treatment Plant (STP)

Effluent Quality Monitoring Report

November 2021

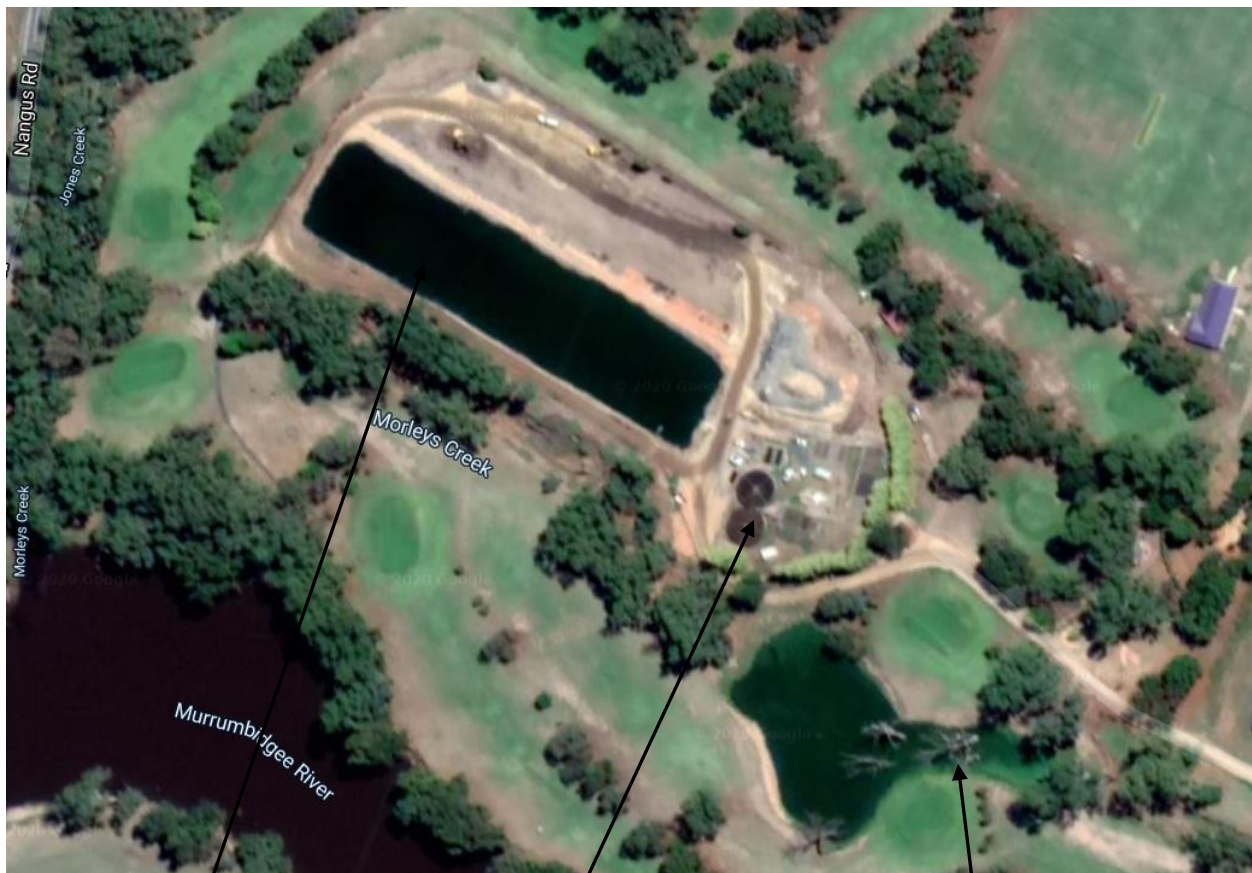
The existing treatment plant consist inlet works, Imhoff tank and trickling filters, humus tank, maturation pond and sludge digester. Digested sludge is discharged into drying beds and disposed at landfill sites. Treated effluent is used to irrigate parks, sporting fields and golf course.

Figure 1- Layout of Gundagai Sewage Treatment Plant

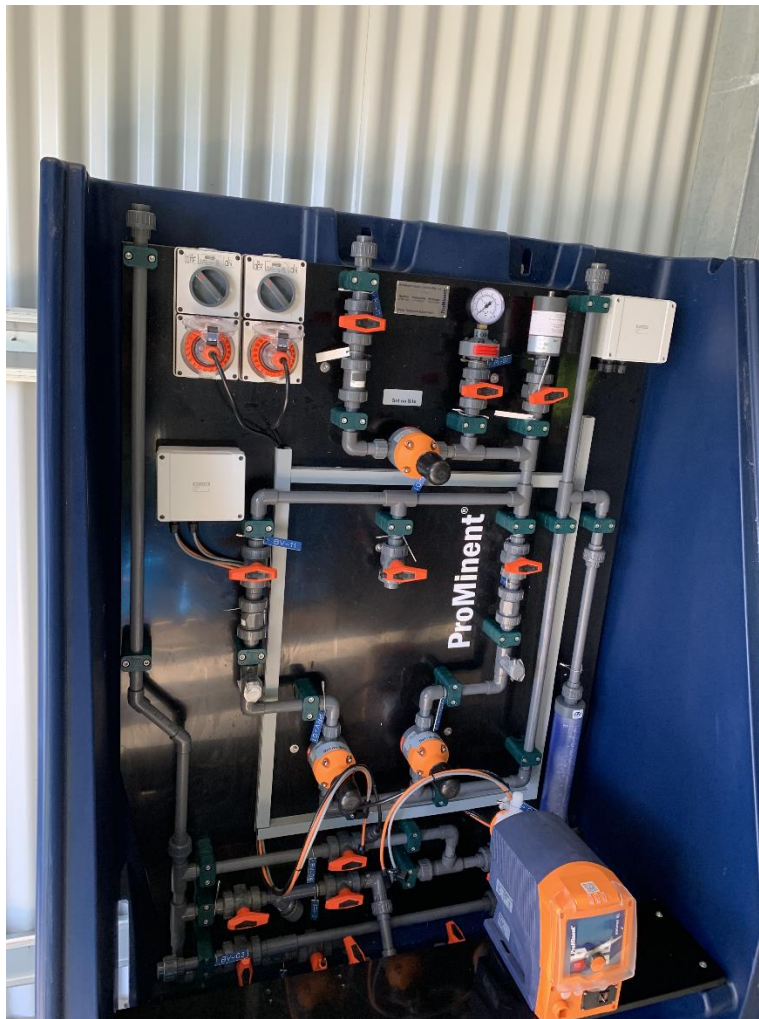
A skid Chlorinator using 12.5% hypochlorite solution was installed, tested and commissioned on 28 August 2020. Subsequent to this the coliform count in the irrigation point has dropped significantly representing an LRV of 3 and above achieved by the disinfection process. Further details can be found in the water quality report in Section 3 of this report.

Figure 3 - Chlorinator

Subsequent to a Risk Management Study on the treated effluent reuse facilities, it was proposed to install a disinfection unit based using sodium hypochlorite solution to reduce the coliform count on the irrigation water and to fully comply with License Requirements.

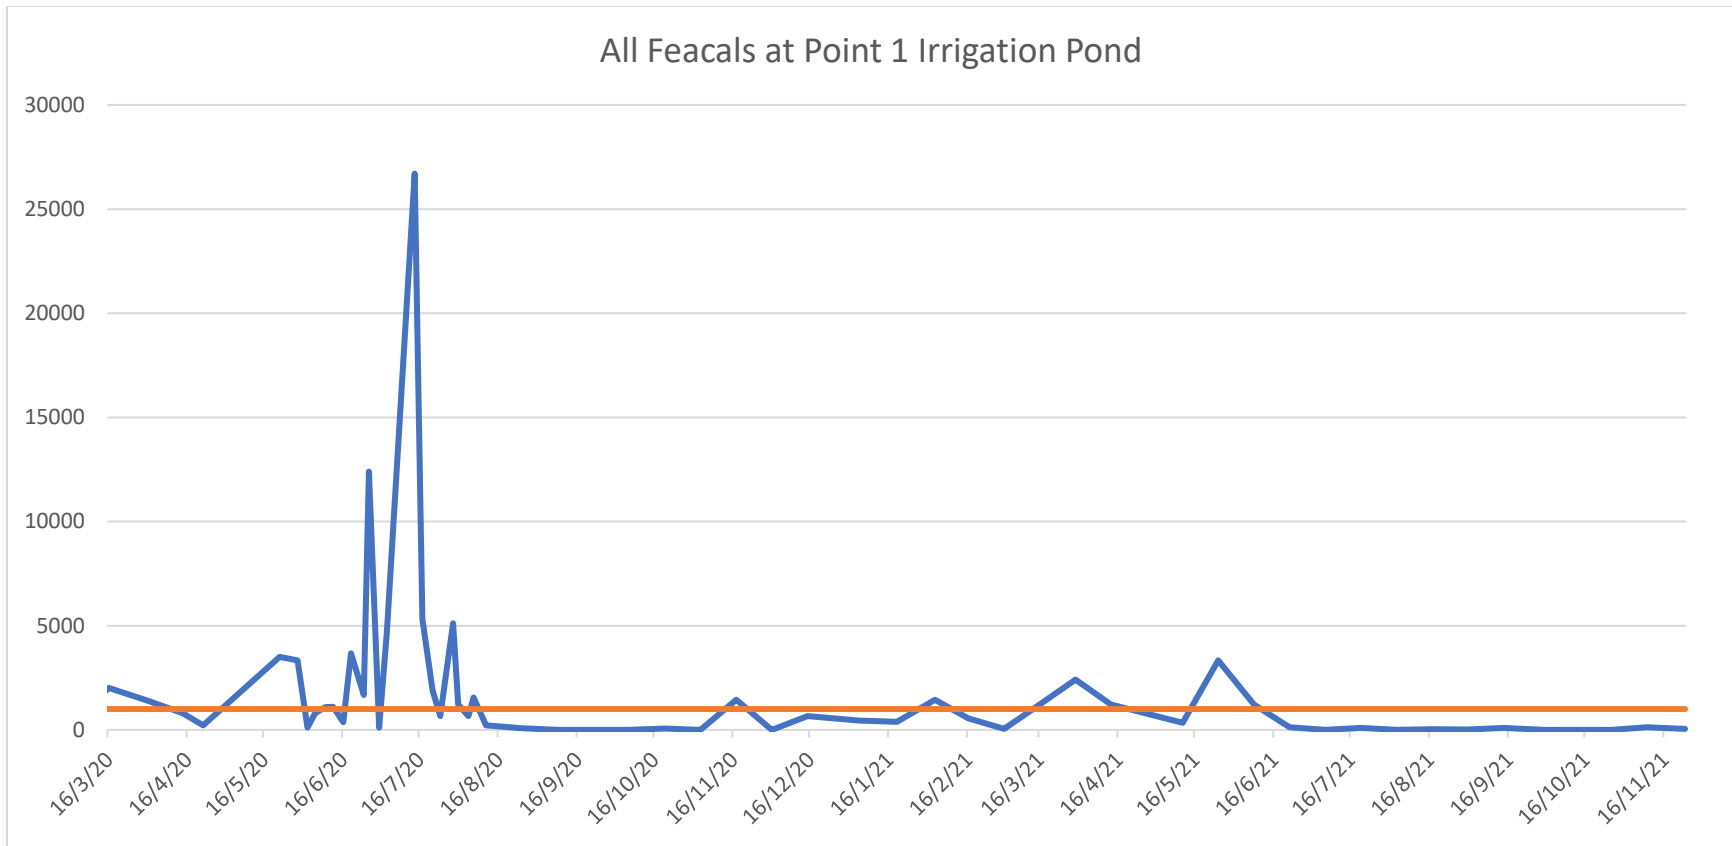
Figure 4 - Fecal Coliform Count (cfu/100 ml) at Irrigation Point

Fortnightly Sampling of Treated Effluent - Bidgee Banks Golf Course (Point 1 Irrigation)	
Date	Faecal coliforms
19/1/21	394
3/2/21	1440
16/2/21	556
2/3/21	55
16/3/21	1210
30/3/21	2420
13/4/21	1220
11/5/21	333
25/5/21	3330
8/6/21	1220
22/6/21	128
6/7/21	9
20/7/21	100
3/8/21	4
17/8/21	30
31/8/21	22
14/9/21	102
30/9/21	<1
12/10/21	4
26/10/21	<1
9/11/21	130
24/11/21	50
Average	1621
