**COOTAMUNDRA-
GUNDAGAI REGIONAL
COUNCIL**

Gundagai Sewage Treatment Plant (STP)

Effluent Quality Monitoring Report

May 2022

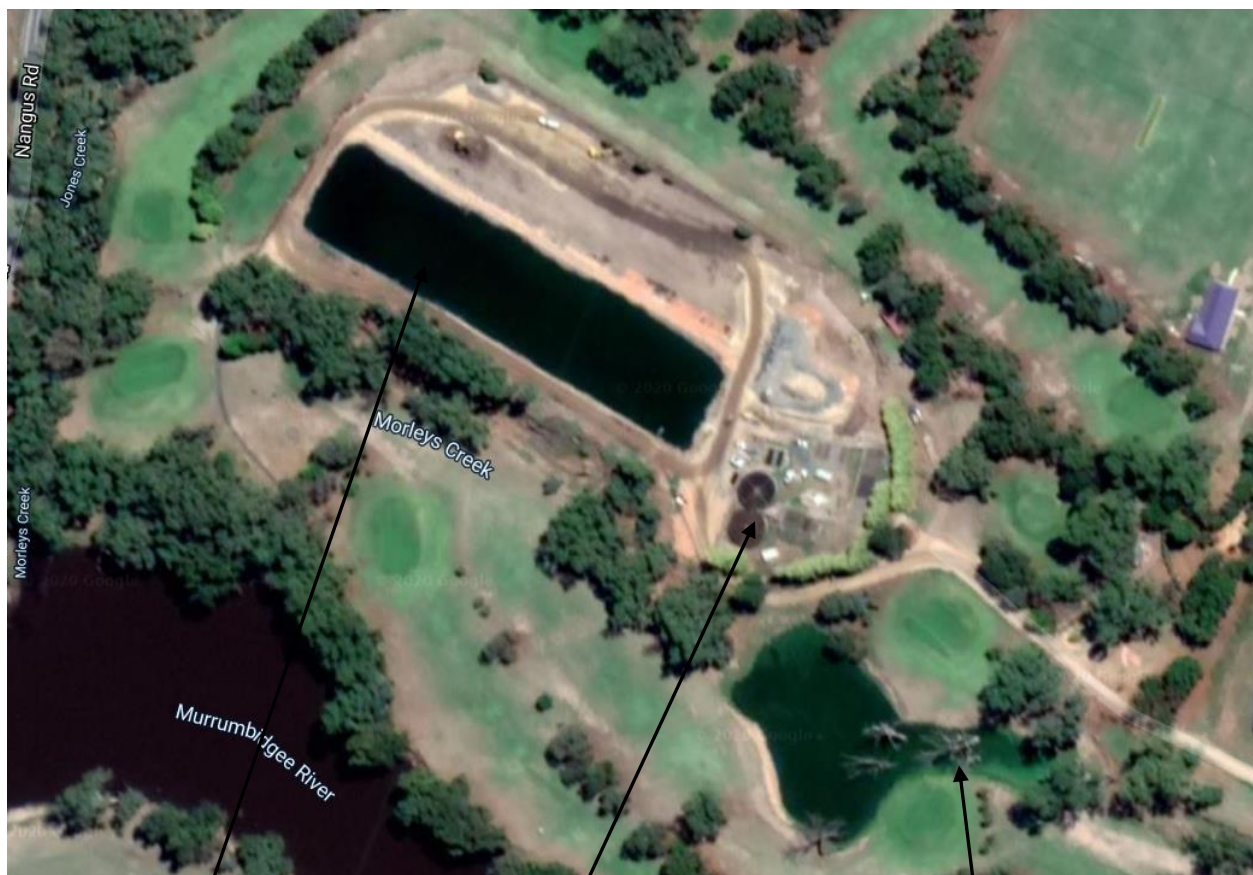
The existing treatment plant consist of inlet works, Imhoff tank and trickling filters, humus tank, maturation pond and sludge digester. Digested sludge is discharged into drying beds and disposed at landfill sites. Treated effluent is used to irrigate parks, sporting fields and golf course.

Figure 1- Layout of Gundagai Sewage Treatment Plant

At present a new Sewage Treatment Plant is under construction with Intermittently Decanted Extended Aeration (IDEA) with sludge dewatering facilities. Upon completion of testing and commissioning of the new treatment plant which is designed to produce higher quality treated effluent for irrigation reuse.

The new plant will have screens, grit removal IDEA process with sludge dewatering facilities. The treated effluent will be disinfected with UV light unit prior to using it for irrigation of parks, garden, sporting fields and golf course. Treated Effluent will be discharged into the nearby waterways while there is not irrigation demand. Construction works are in progress and more than 80% completed.

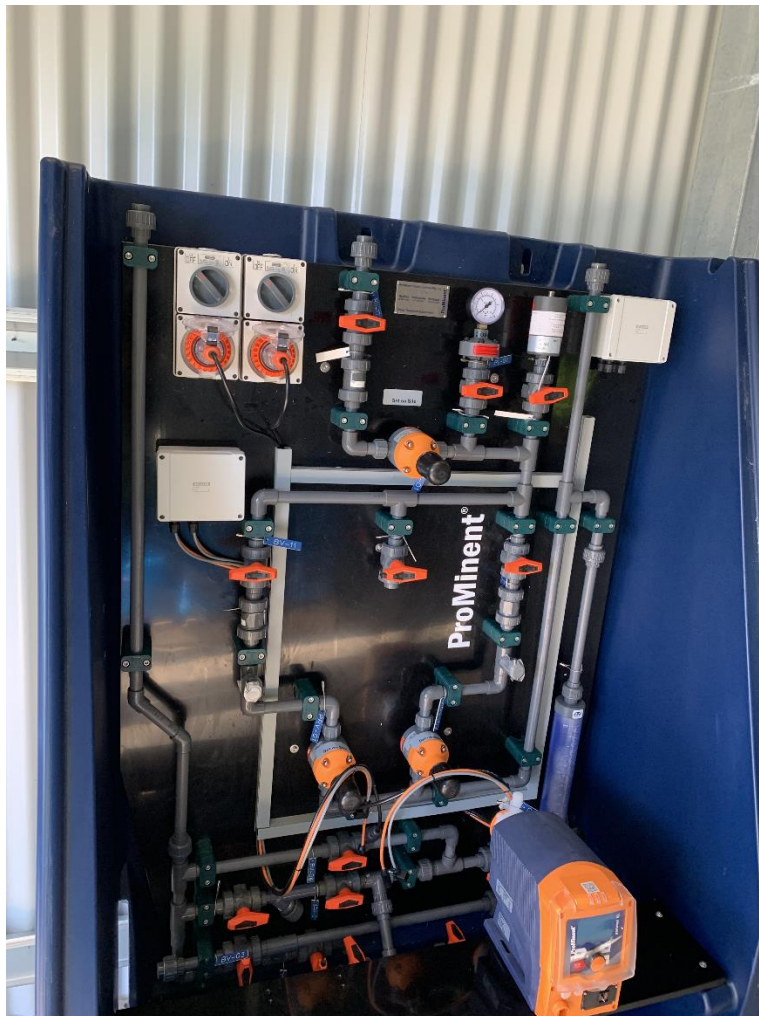
A skid Chlorinator using 12.5% hypochlorite solution was installed, tested and commissioned on 28 August 2020. Subsequent to this the coliform count in the irrigation point has dropped significantly representing an LRV of 3 and above achieved by the disinfection process. Further details can be found in the water quality report in Section 3 of this report.

Figure 3 - Chlorinator

Subsequent to a Risk Management Study on the treated effluent reuse facilities, it was proposed to install a disinfection unit based using sodium hypochlorite solution to reduce the coliform count on the irrigation water and to fully comply with License Requirements.

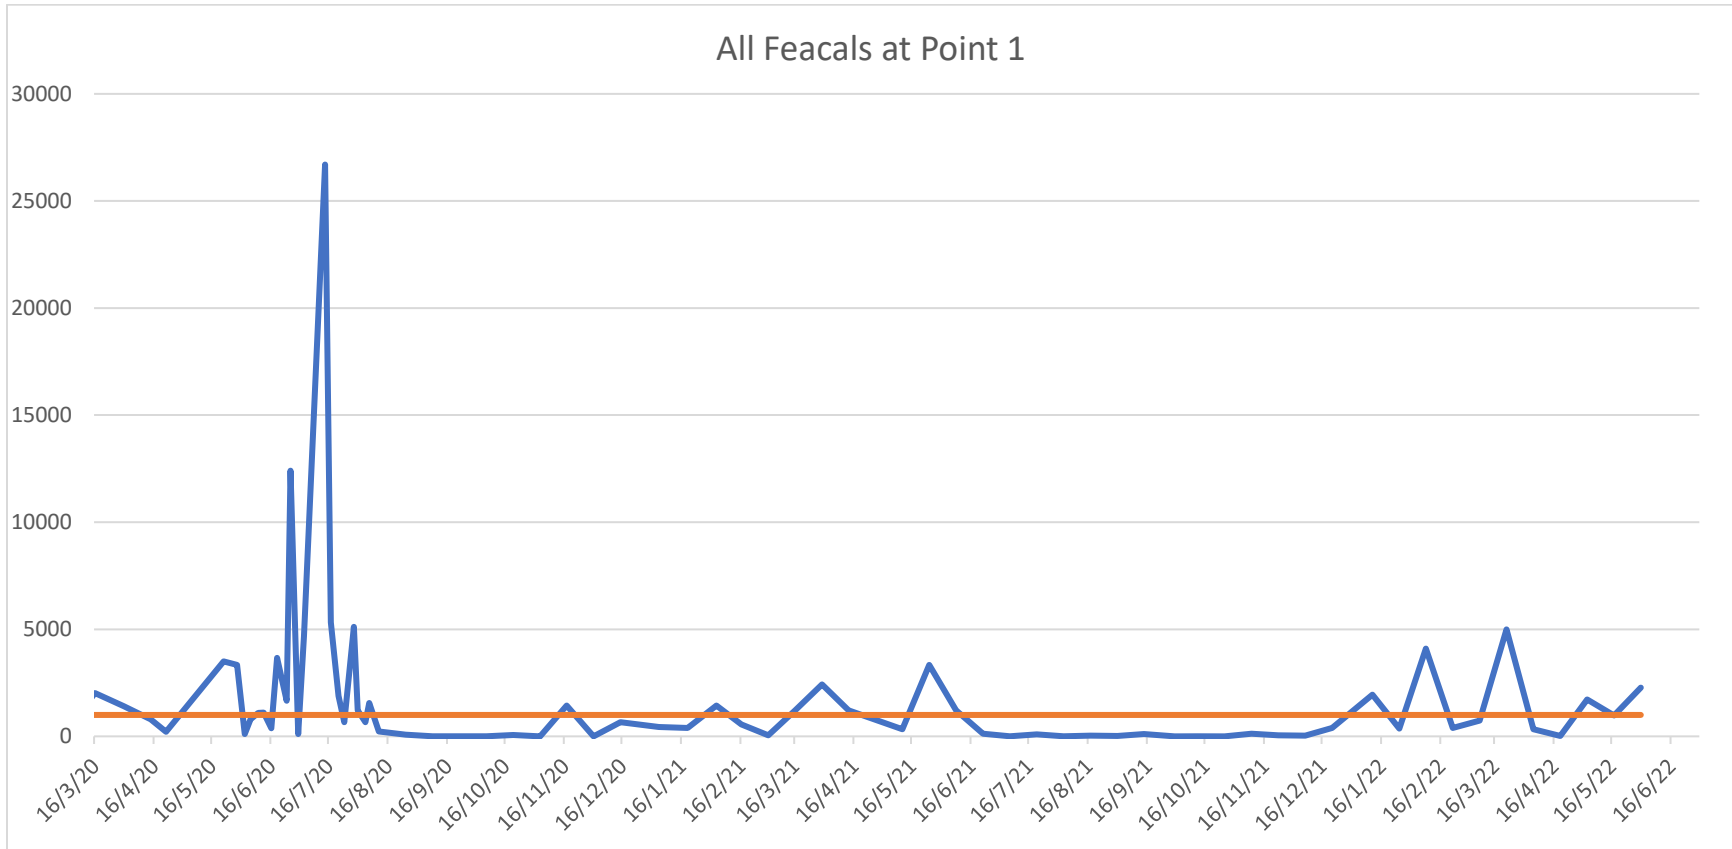
2.3.3 Coliform Count at Golf Course Irrigation Point

Figure 4 - Fecal Coliform Count (cfu/100 ml) at Irrigation Point

Fortnightly Sampling of Treated Effluent - Bidgee Banks Golf Course (Point 1 Irrigation)	
Date	Faecal coliforms
Average	1563
