GUNDAGAI RAILWAY BRIDGE AND VIADUCTS – CONVERSION TO RAIL TRAIL

Feasibility Report

01 MAY 2018

Report No F0001-10005572-NSR-01

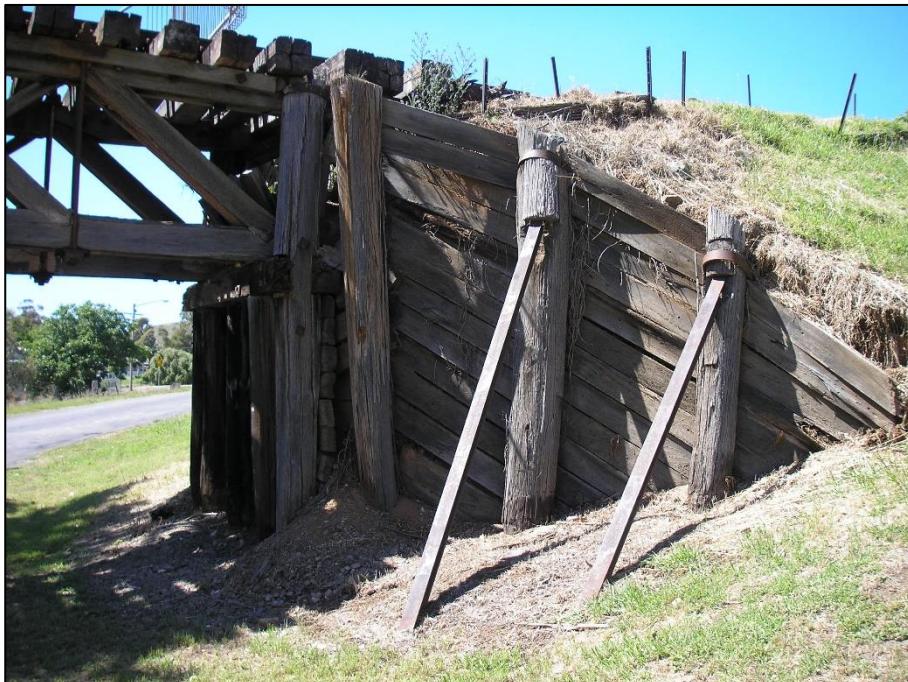
Country Abutment (November 2010):

As a comparison, the following photo is of the Country abutment at Gundagai in November 2010.
